**STATE OFFICE BUILDING
BUILDING ASSESSMENT
WICHITA, KANSAS**

GLMV PROJECT 13052.000

December 16, 2013

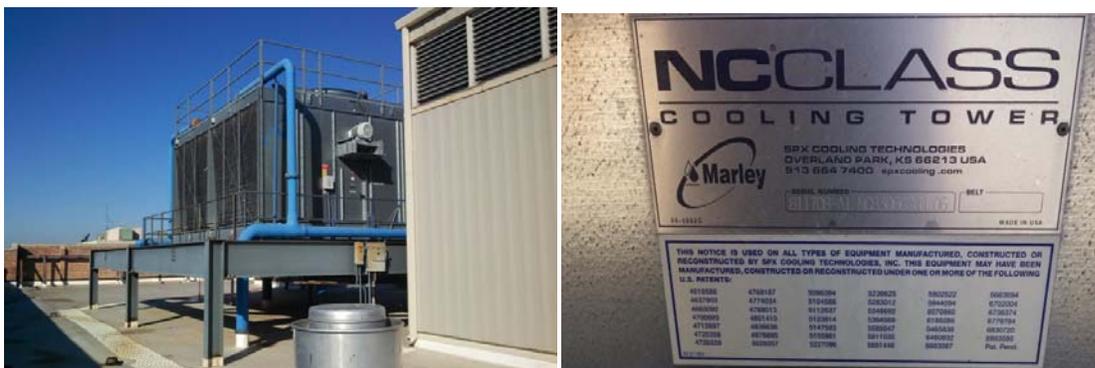
The cooling tower is a two-cell (CT-1 and CT-2) Marley Tower that was recently replaced, and appears to be in good condition (see photos below).

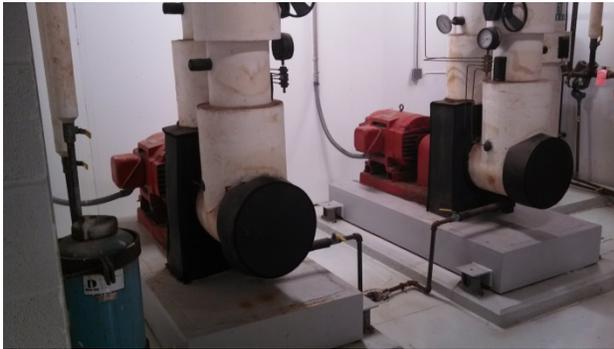
Two variable-volume, base-mounted, end-suction, 75-horsepower pumps (P-1 and P-2) circulate water in the “secondary” loop (see photo below). These pumps are driven by variable frequency drives (VFDs) and increase or decrease speed based on differential pressure in the chilled water system.

According to the ASHRAE Handbook – HVAC Applications, base-mounted pumps have a median service life of 20 years. Inline pump average operational life is closer to ten years. As a result of all pumps being rebuilt in 2006, it is expected that there is still a significant amount of service life left in the units. The two vertical inline, primary pumps serving the two chillers are approaching their average service life expectancy.

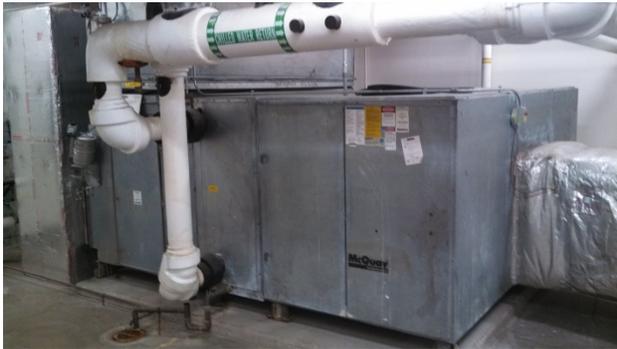
Generally speaking, the basement and Floors 2 through 6 are laid out in similar fashion with one VAV AHU located in a mechanical room for the west building and another located in a mechanical room for the east building. Following is a representative photo of one of these units.

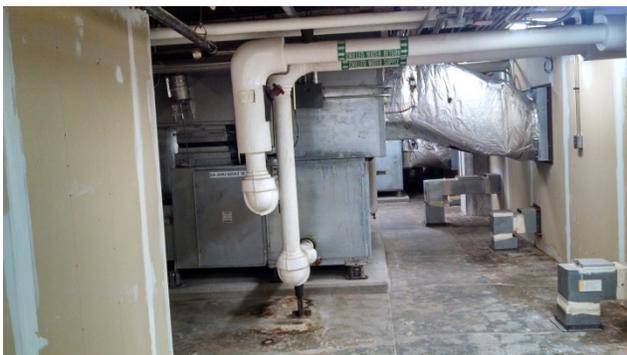
The first floor is served by three AHUs (AHU-11, AHU-12, and AHU-13) located on the mezzanine above (AHU-12 and AHU-13 are pictured below).

Expected service life for modular air handlers of the type installed in this building is in the range of 20 to 25 years. The building operator has indicated that the cooling coils have been cleaned, and the VFDs have been replaced within the last five years. There was no visible leaking of the unit casings.

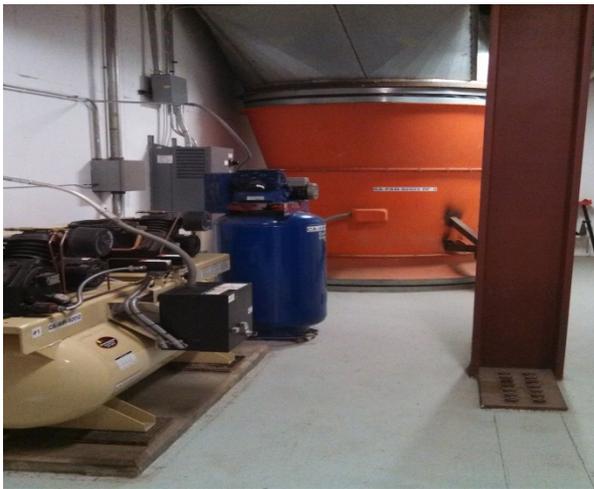
Relief for building pressurization due to minimum OA ventilation or economizer operation is generally provided via inline relief fans connected to the relief shafts in the east and west buildings. RF-1 is located in the mezzanine and relieves air from the east basement. RF-2 resides in a penthouse on the roof of the west building and relieves air from the west building. RF-3 is located in the east building mechanical penthouse on the roof (see photo below)

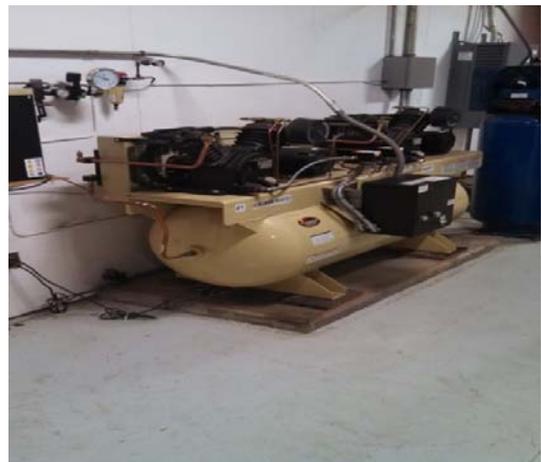
During the remodel in the 90s, the Contractor installed a pneumatic temperature control system for the building. Since then, the system has been modified extensively, including changing most of the system out for a Johnson Controls, Inc. (JCI) Metasys Direct Digital Control (DDC) system. This left only the water valve and damper actuators as pneumatic. According to the building operator, the JCI DDC system was reported to have been installed in 2009, and the air compressor serving the pneumatic control tubing still being utilized was replaced in 2011 (see photo).

According to ASHRAE, pneumatic control equipment has a median service life of 20 years. As a result, the original pneumatic components of the building have reached the end of their expected service life.

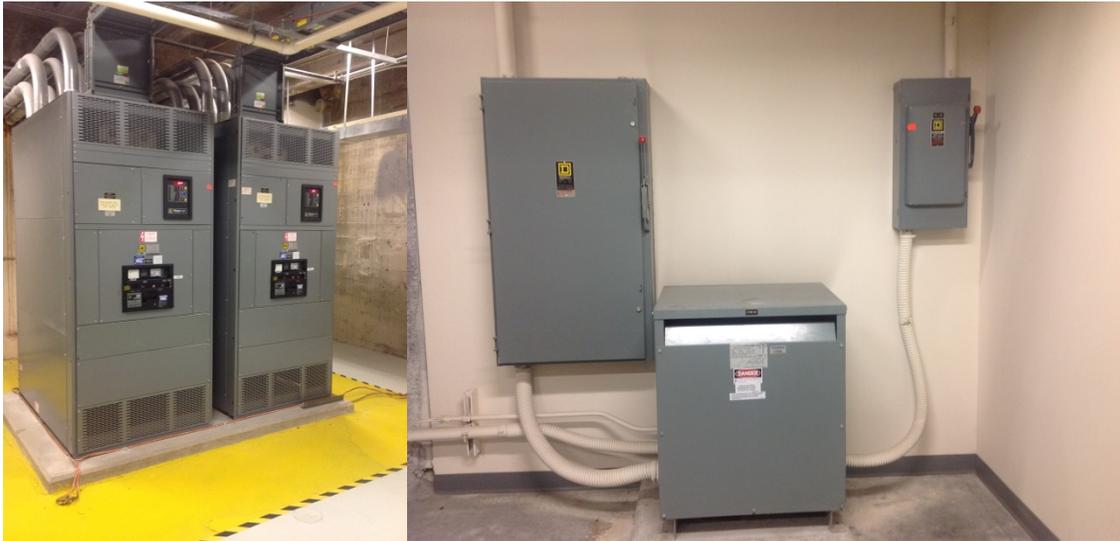
The building is fed by two utility services from Westar's downtown underground electrical system. Two 1,500-kVA transformers located in an underground substation-type vault feed two 3,000A, 480/277V, three-phase, four-wire main circuit breakers located in separate switchboard-type distribution cabinets. Each of these main breakers feeds 3,000A busducts that are routed vertically through the eight floors of the building. One service feeds all of the mechanical equipment, while the other service feeds all of the lighting and receptacles. According to the PowerLogic meters installed on these switchboards, MSB-1 indicated a maximum demand load of 1,081A and MSB-2 indicated a maximum load of 558A. Both services have a large amount of capacity for expansion.

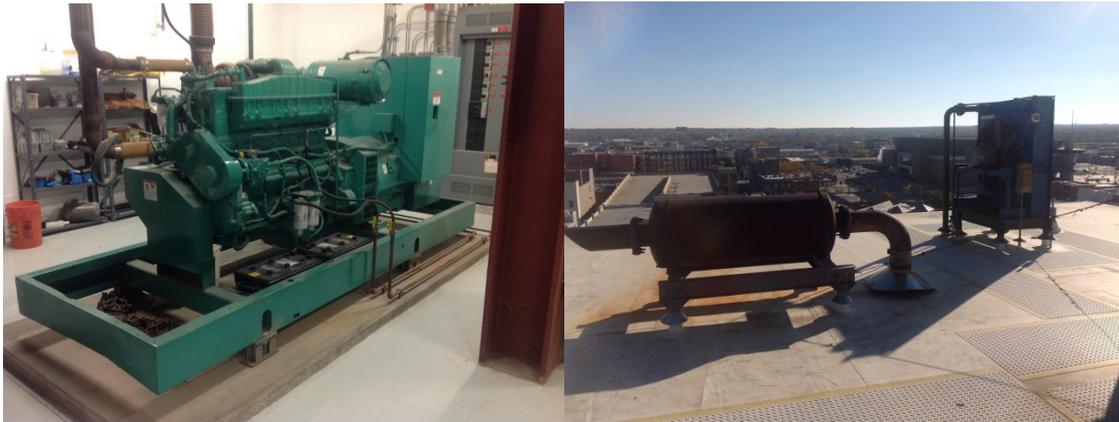
A 350-kW, three-phase, 277/480V Cummins emergency diesel generator is installed on the eighth floor. The exhaust muffler and radiator are remote mounted on the roof directly above the generator. A 600A unit-mounted circuit breaker feeds a single 800A automatic transfer switch, which then feeds an 800A emergency distribution panel. This distribution panel feeds elevators, supply air fans, a make-up air unit, and the emergency lighting panelboards.

The generator appeared to be clean and in good condition with very little sign of wear. The hour meter indicated 364.8 hours of runtime, or approximately 18.25 hours per year. According to the building maintenance personnel, the generator is started and allowed to idle monthly. Once a year, the generator is serviced by a professional technician and is load bank tested.

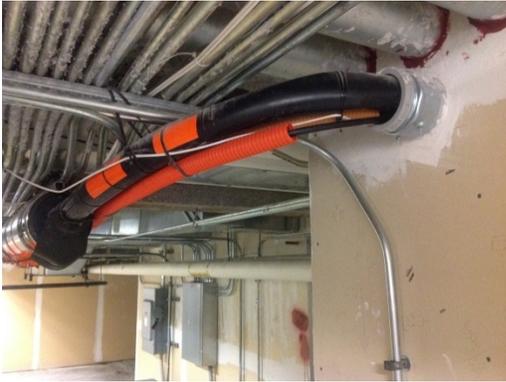
The main utility demark is located in the mezzanine level. From this room, copper and fiber optic backbone cables are routed to satellite telecommunications closets. Overall, cabling was well organized; only a few locations were noted where cabling was poorly supported.

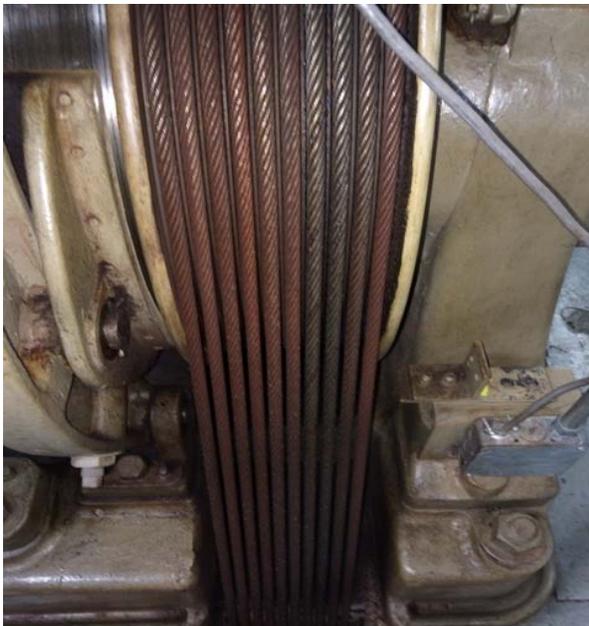
1. Elevators 4 through 6 had rouge on most of the ropes (hoist cables) that indicates rust or deterioration of the ropes (see attached picture). Other elevators also showed signs of rouge and dryness of the hoist ropes. It should be noted, however, the diameters of all the hoist ropes on all the elevators were measured to find none in violation of the code requirements. Despite this finding, lubrication of the ropes, as recommended by the manufacturers of the hoist ropes, is highly recommended to extend the useful life and provide proper operation of the hoist ropes.

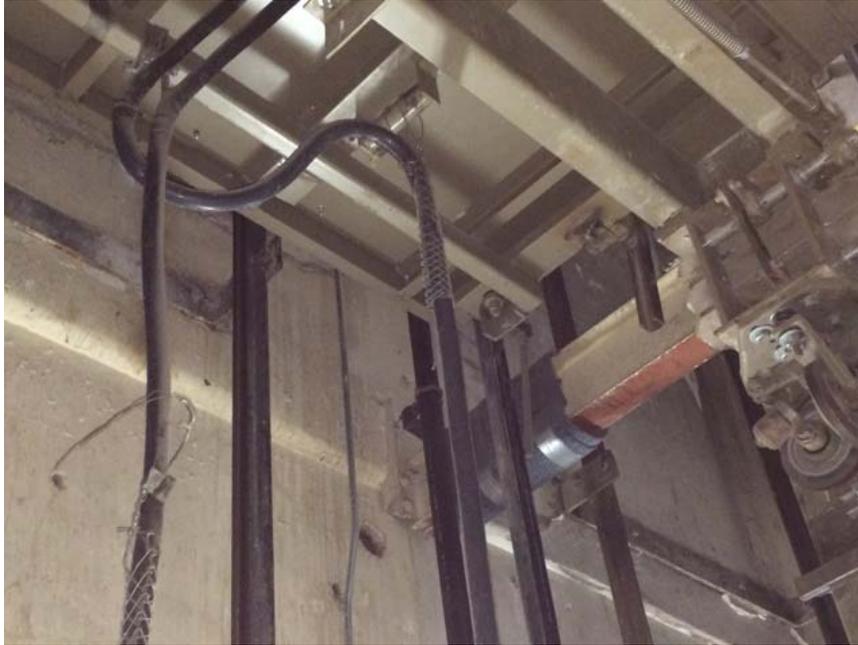
2. Elevator 4 had a broken “kellum grip” used to hang the traveling cable on the underside of the elevator. Please see the picture below. While this is not a major concern, it should be corrected to take the excess weight of the traveling cable off of the single hanger.

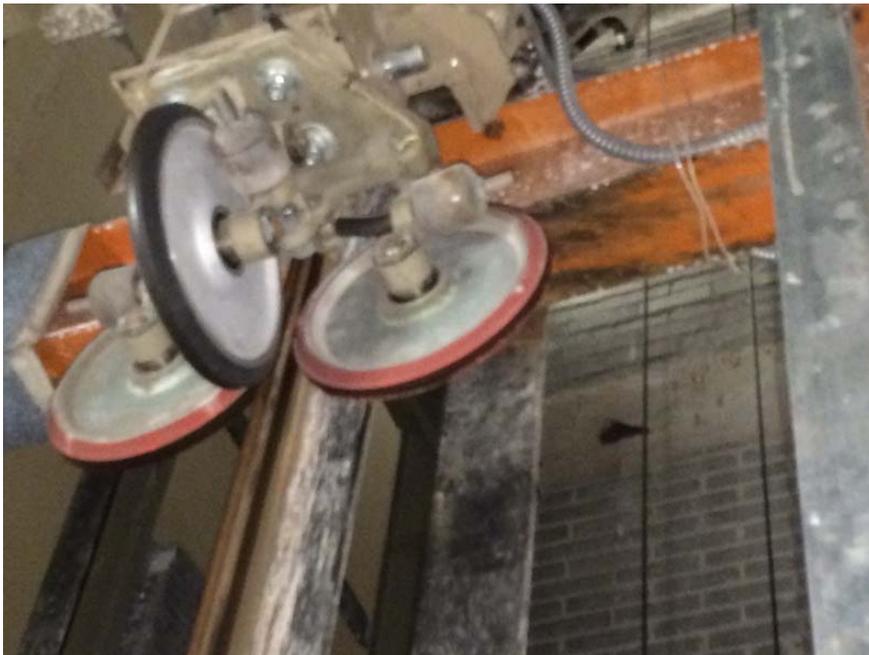
3. Elevator 1 has a few guide rollers that should be replaced, since they are starting to deteriorate. This will adversely affect the ride quality of this elevator.
