**STATE OFFICE BUILDING
BUILDING ASSESSMENT
WICHITA, KANSAS**

GLMV PROJECT 13052.000

December 16, 2013

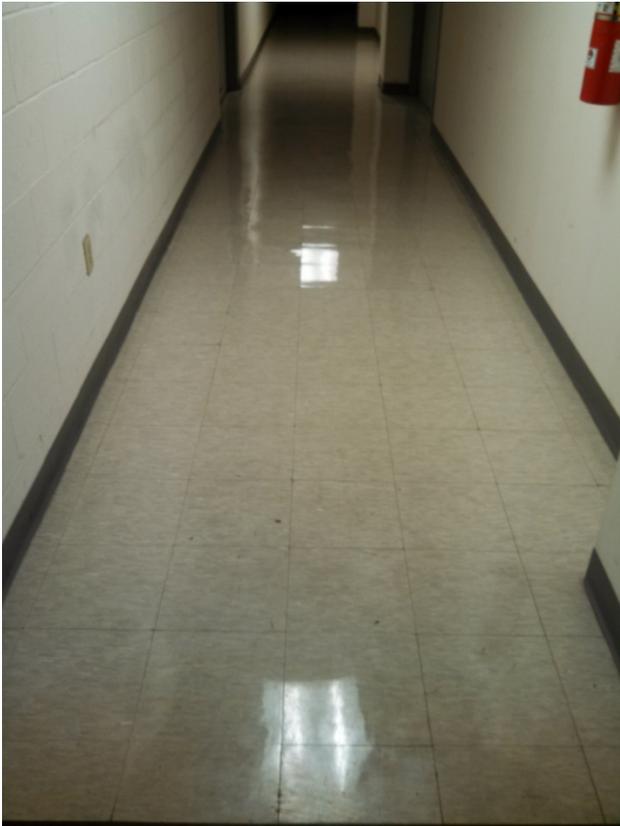
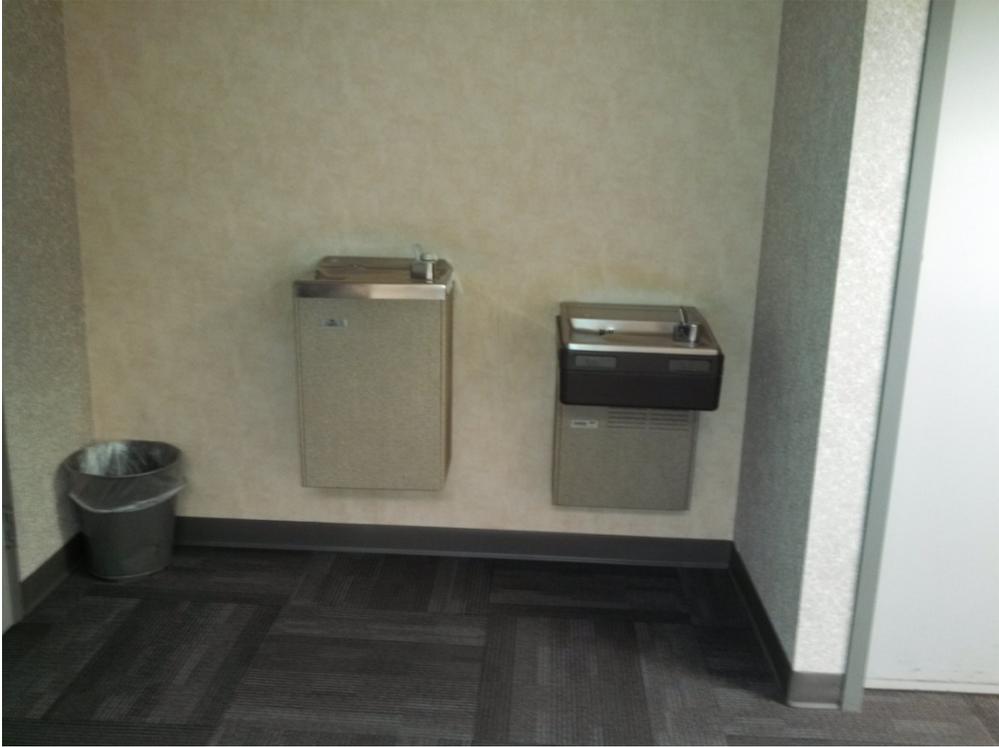
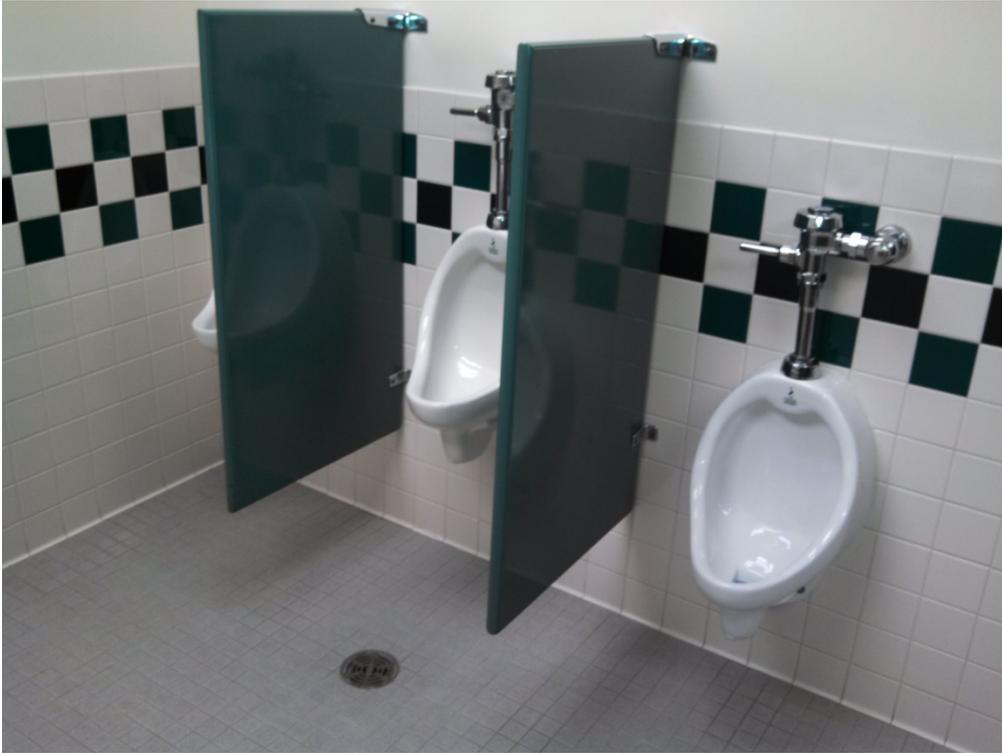
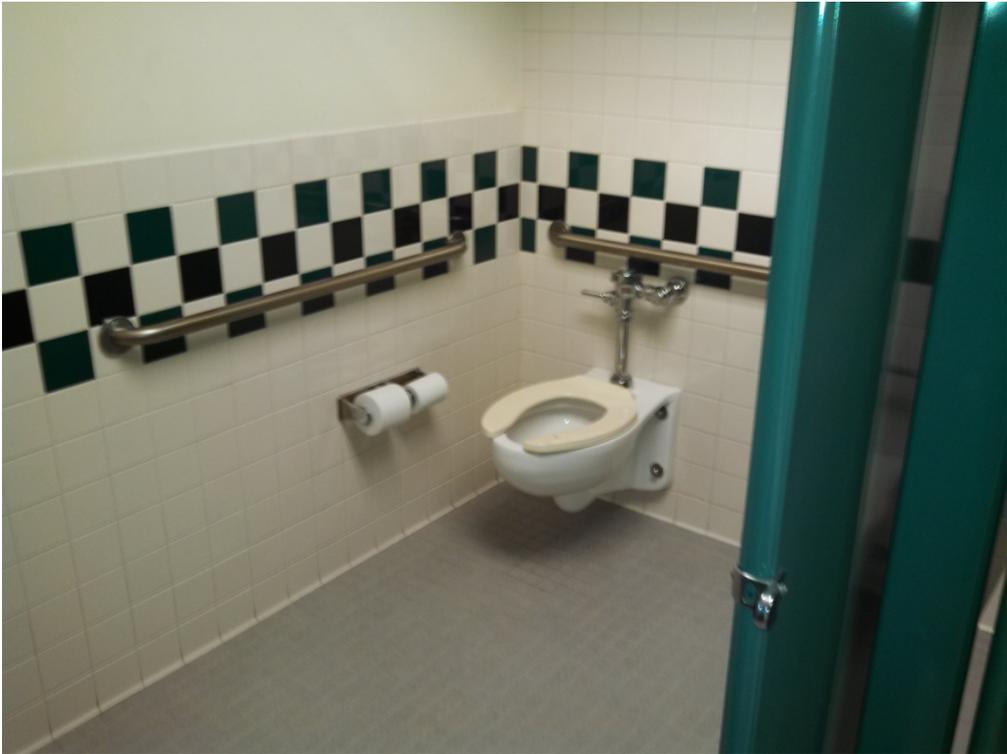
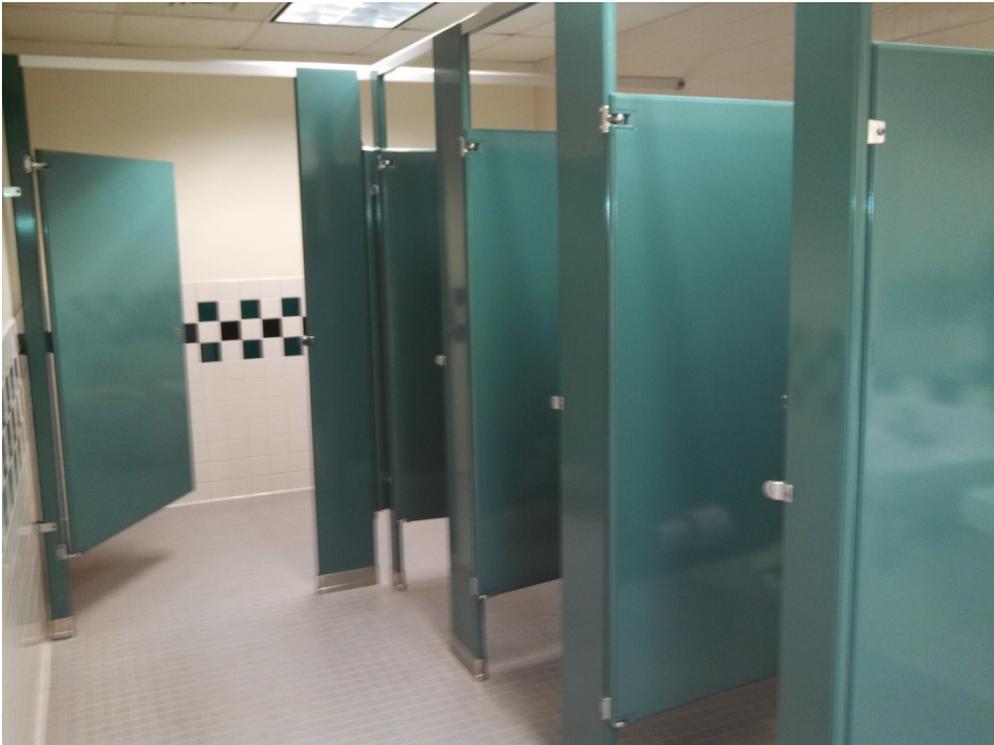
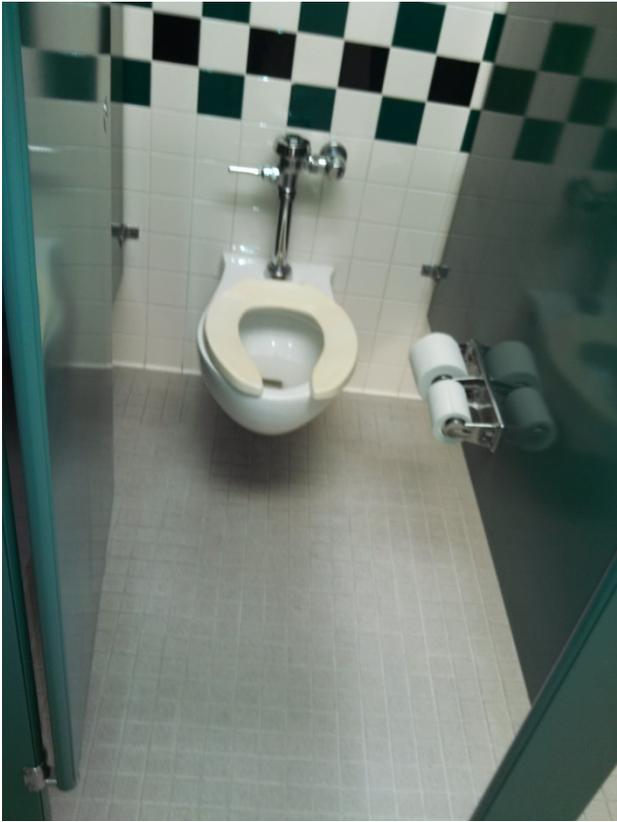
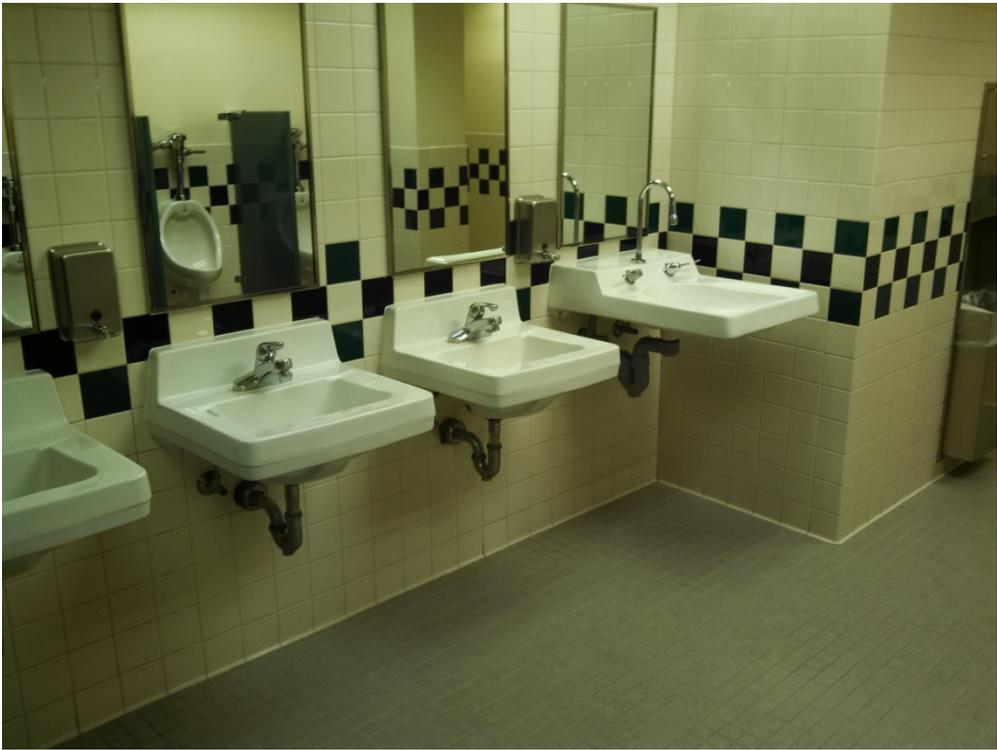
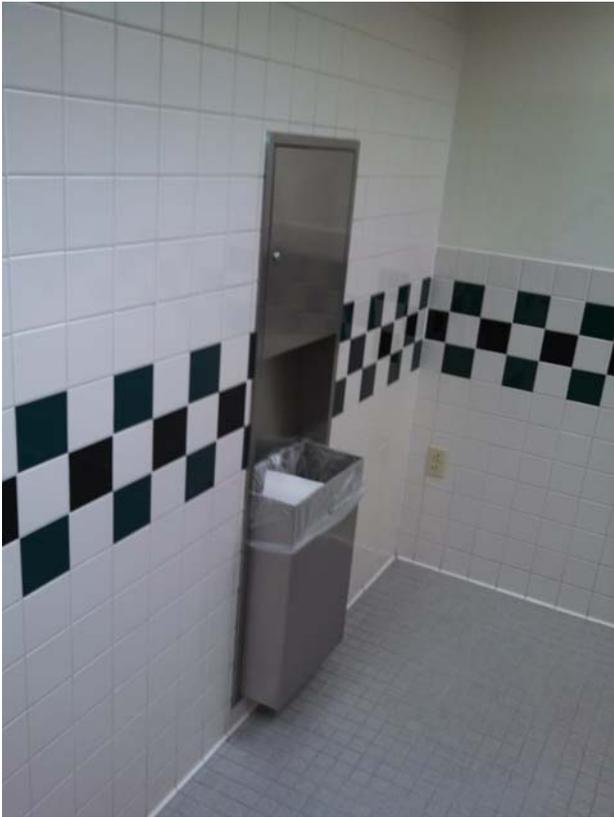
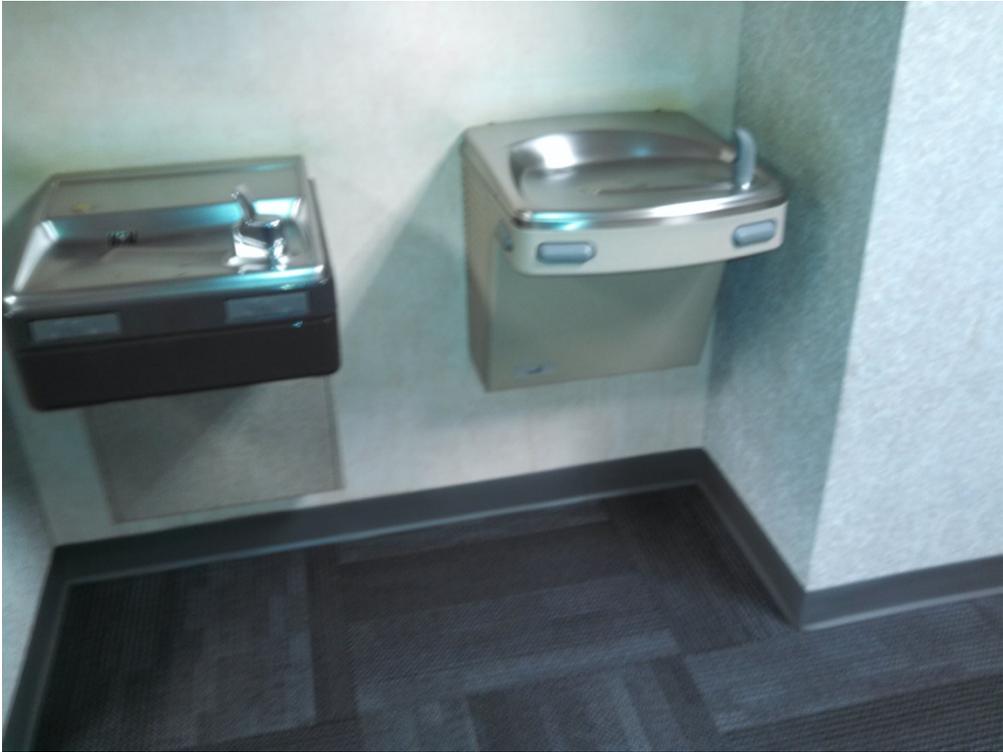
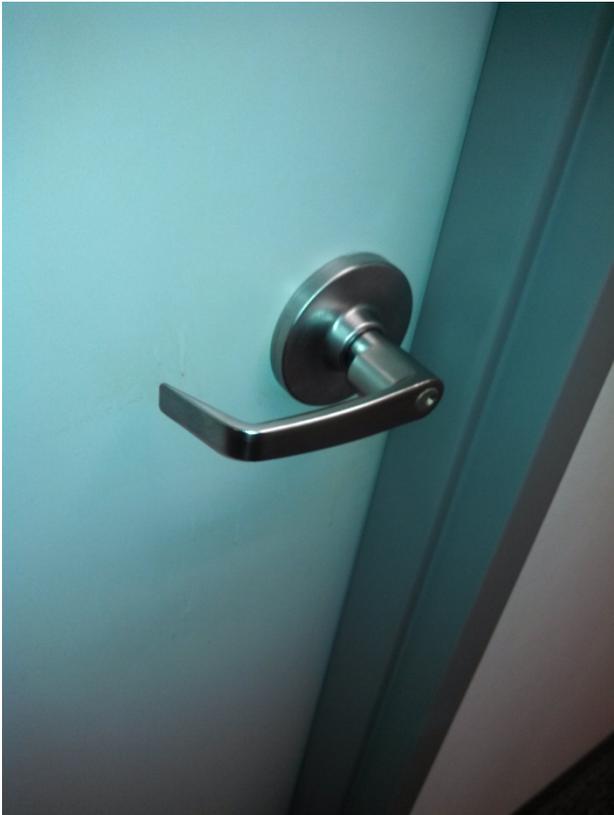
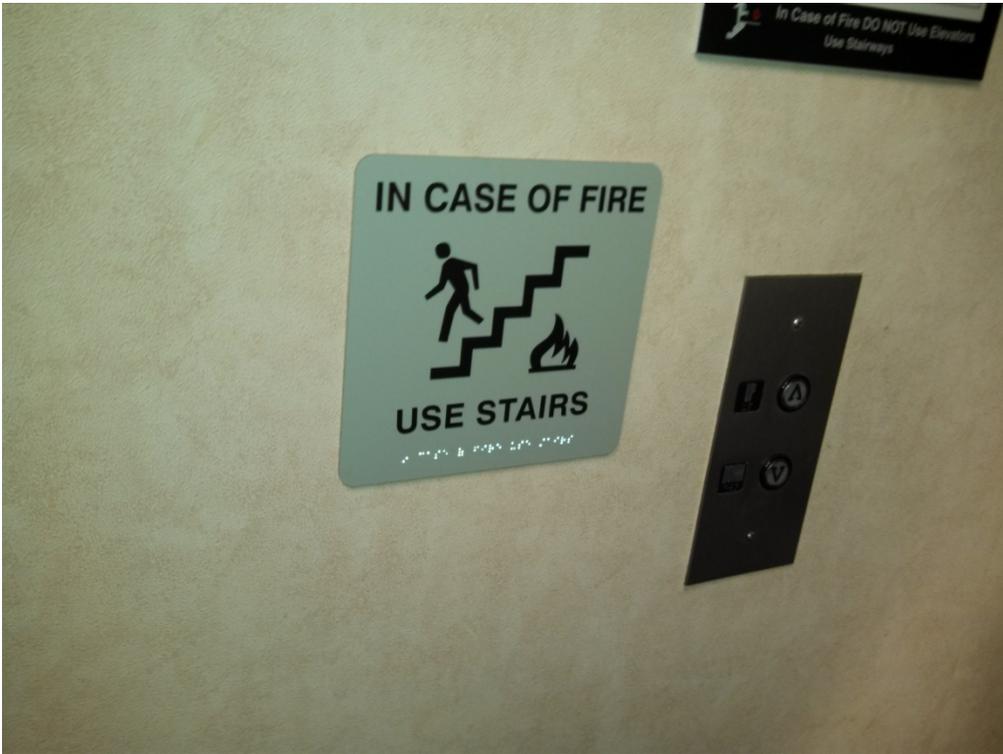
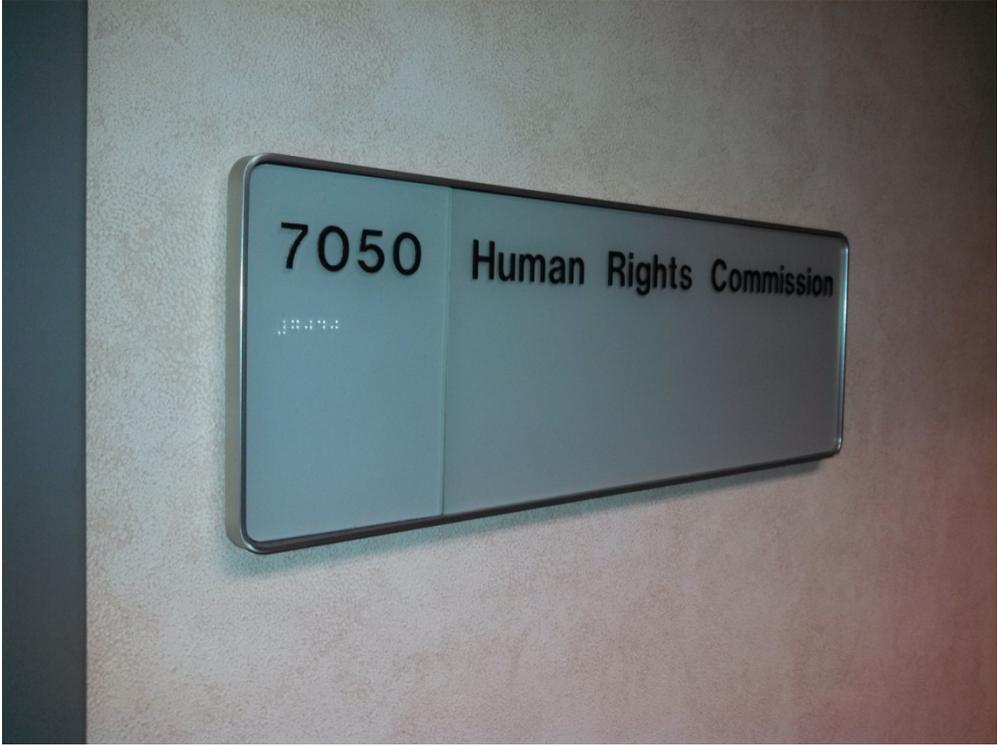
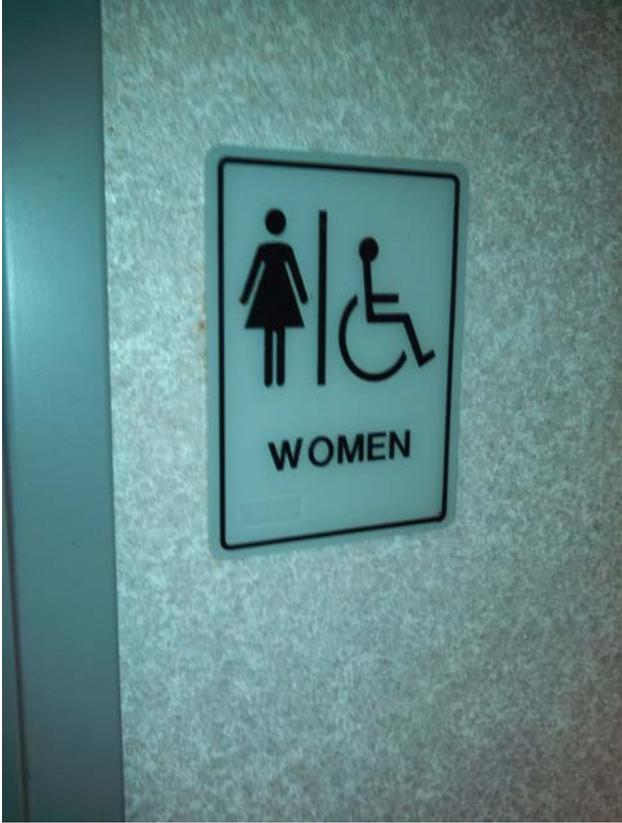
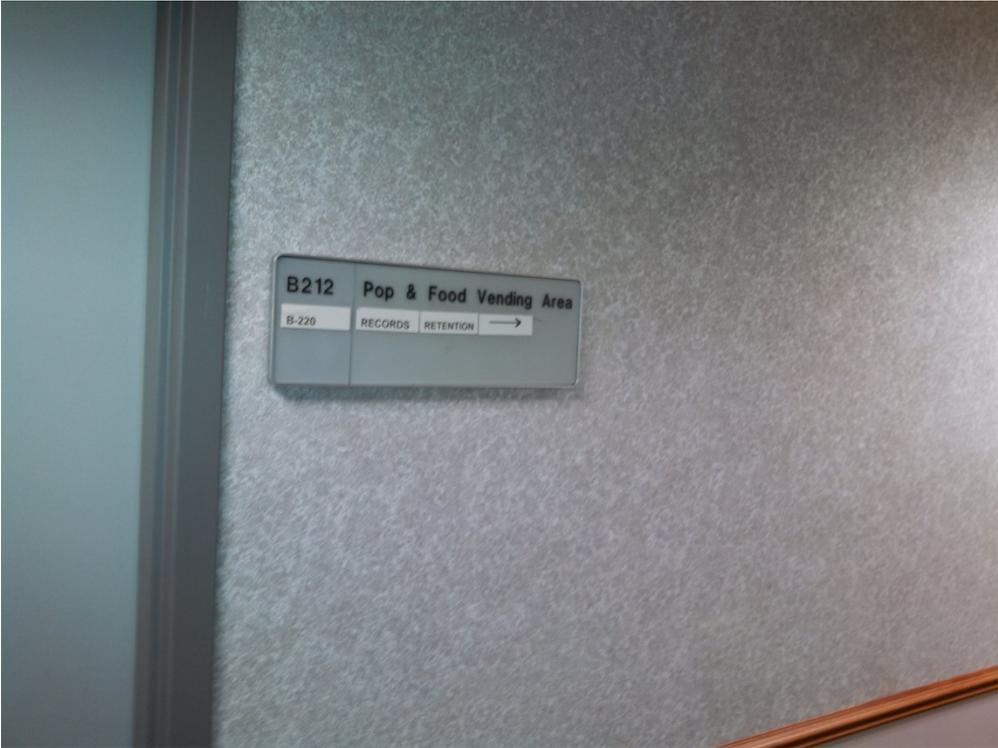
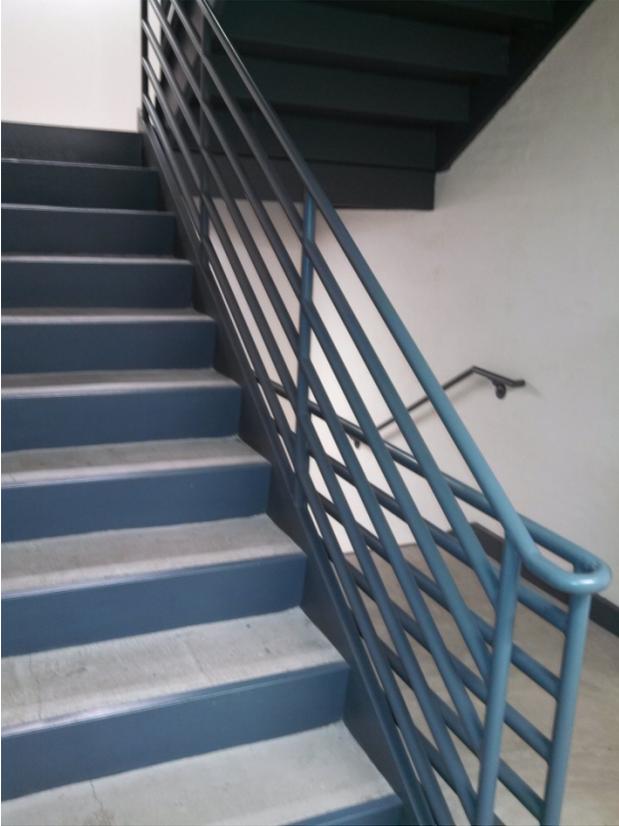
- In general, the facility appears to provide barrier-free accessibility (to 1991 ADA Standards) to handicap accessible parking on William Street.
- Areas of refuge are not found in stairwells; however, they are provided in protected lobby areas on each level located in front of elevators within the corridor system.
- Floor elevation changes are accomplished with compliant sloping ramps.
- Restrooms appear to provide adequate turning radii, compliant toilet and sink fixtures, grab bars, and toilet compartments.
- Compliant drinking fountains were observed to be high/low of mixed style and manufacturer.
- Public spaces are equipped with Braille signage.
- Corridor widths appear to be ADA compliant.
- Door pull side and push side clearances appear to be in general compliance. No non-compliant door clearances were observed.
- Handrails in stair towers are on one side only (non-compliant).

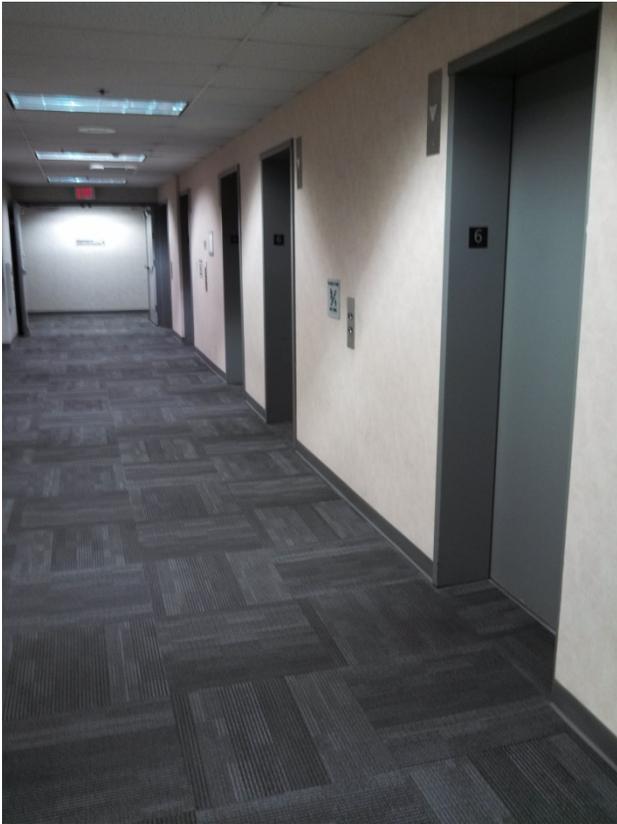
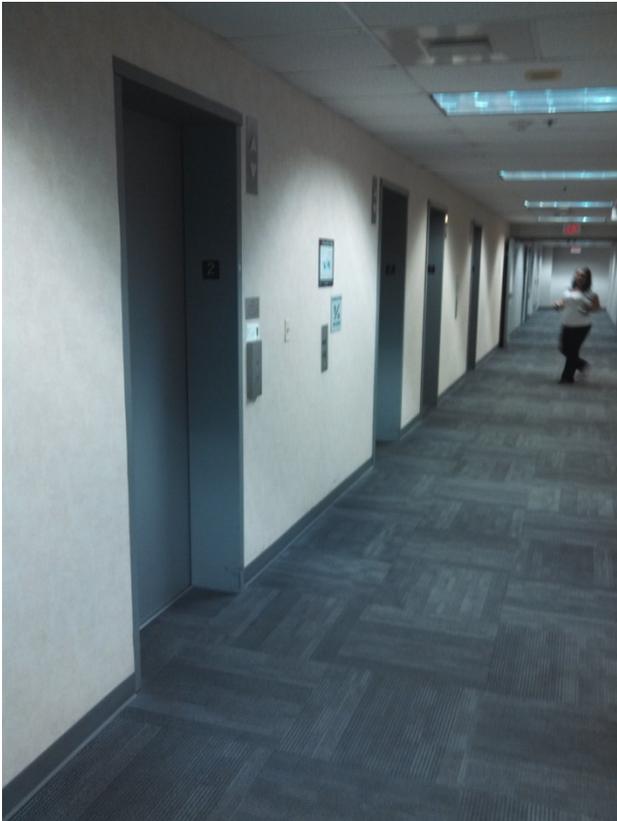
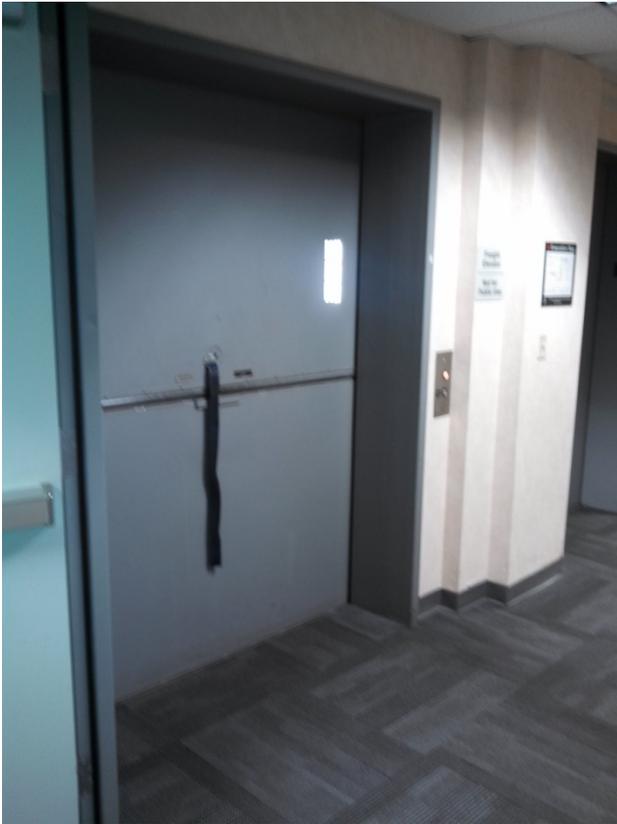
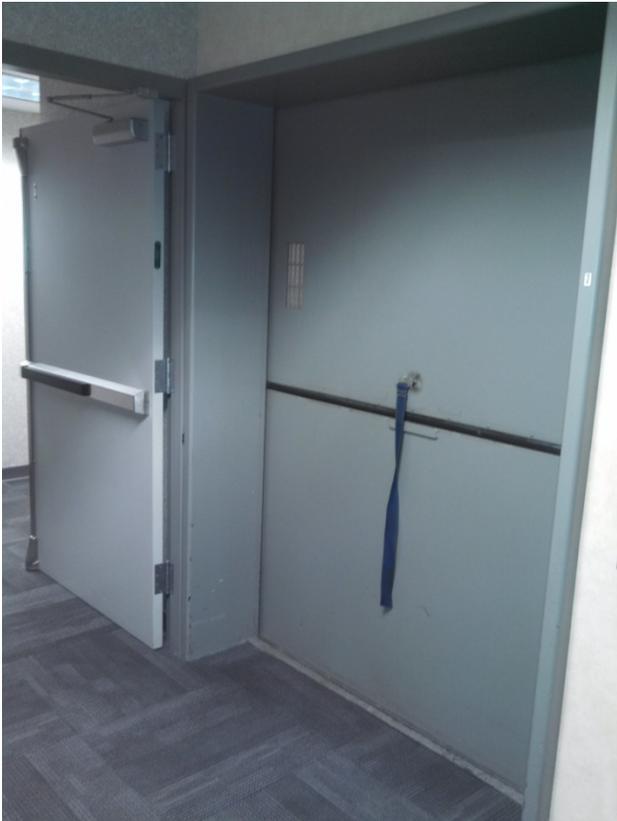
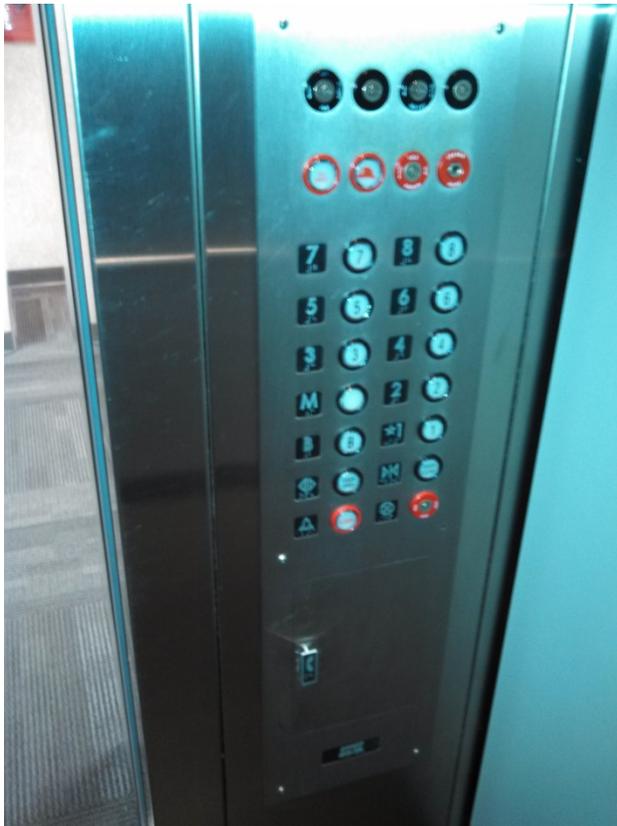
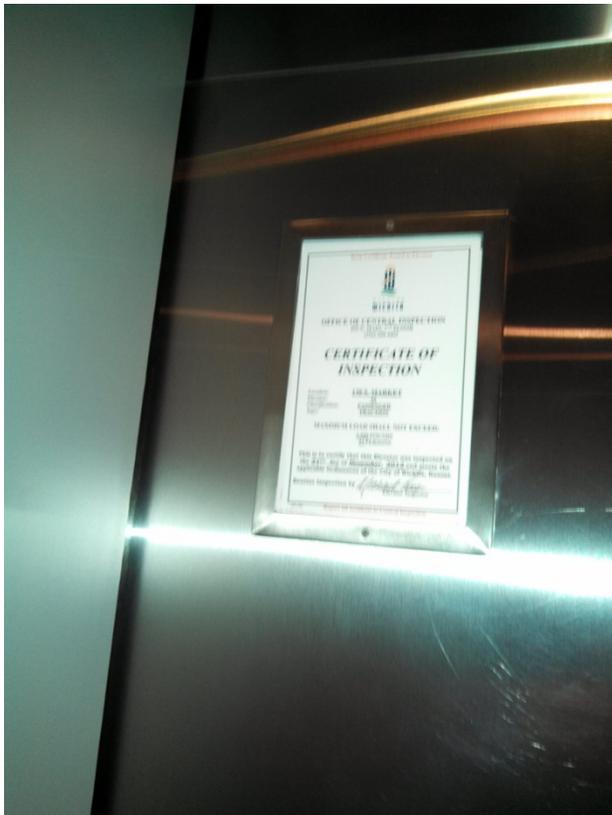
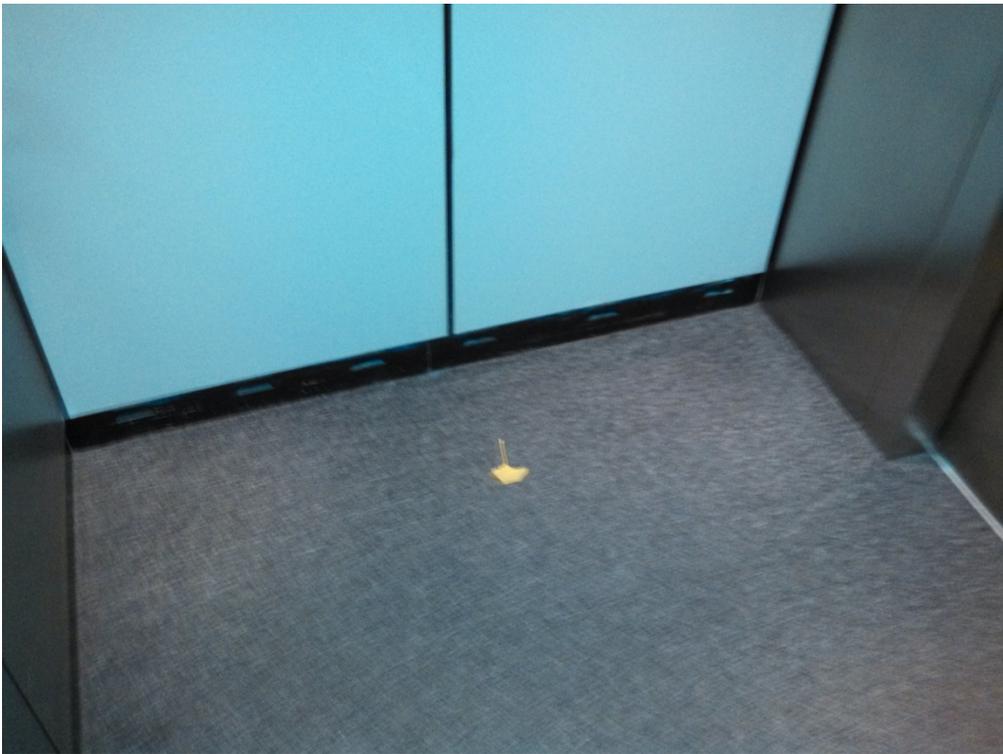
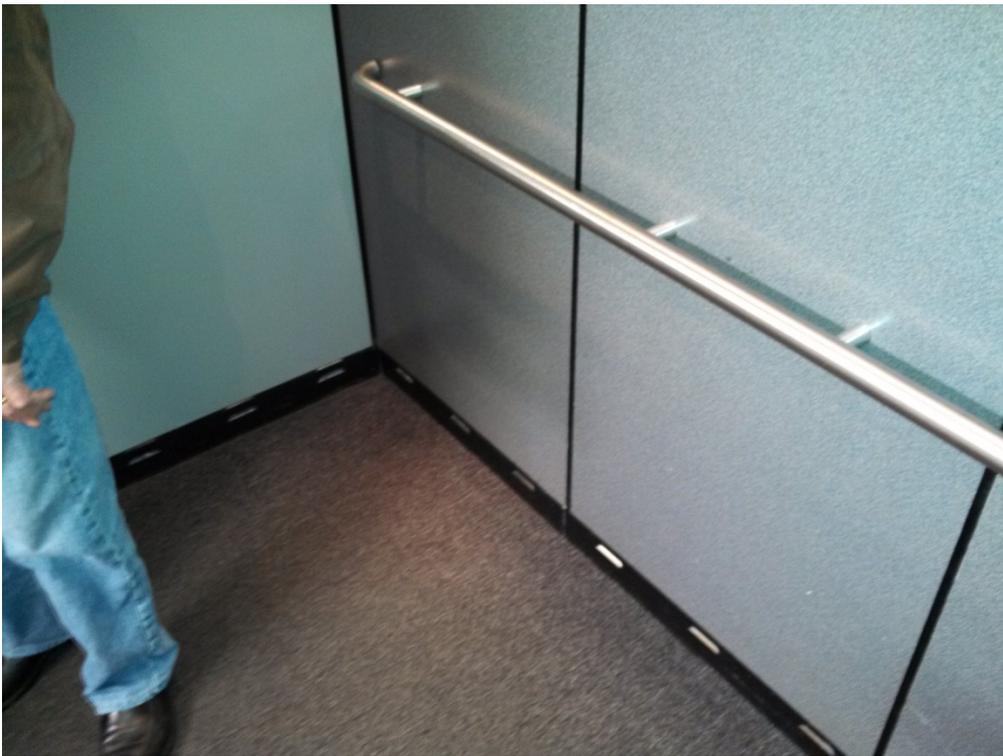
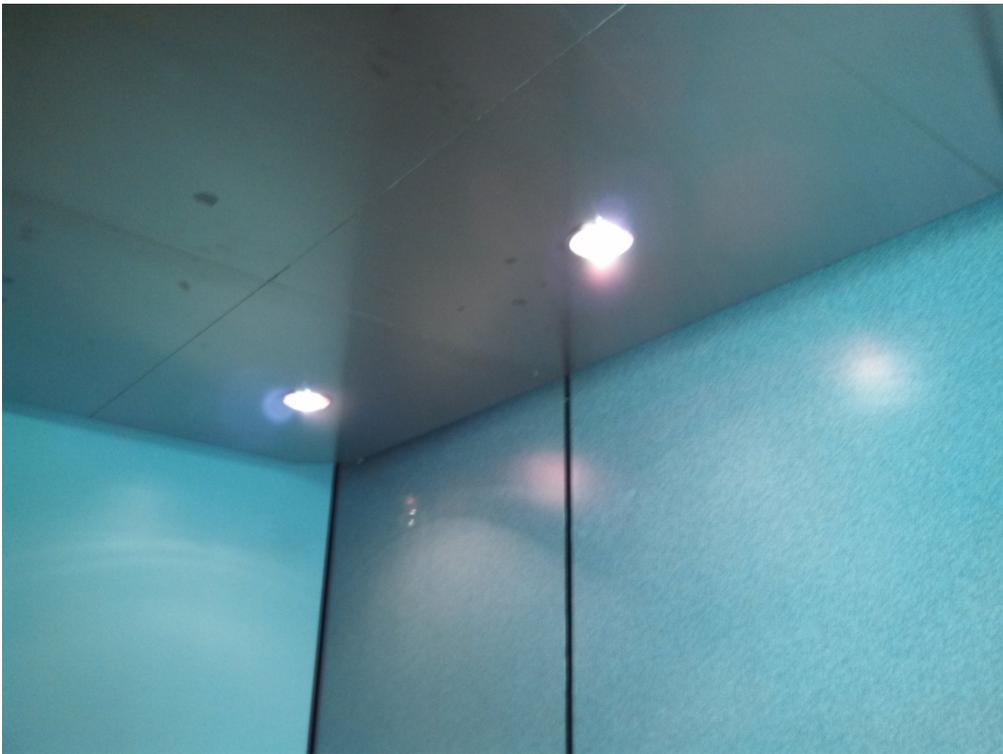
- West Wing: Bank of two passenger elevators.
- East Wing: Bank of four passenger elevators and one freight elevator.
- Elevator service to seventh and eighth floors is limited. Refer to attached Plan Sheets for elevator configuration.
- Floor Finishes: Well worn. Replacement at Owner's discretion.
- Wall Finishes: Worn but serviceable. Replacement at Owner's discretion.
- Ceiling: Lighting levels are on the dim side. Lamps appear to have been replaced with non-standard lamps. Replacement at Owner's discretion.
- Inspection certificates are posted.
- Stainless-steel doors appear to be in good condition.
- Call buttons in corridors fall within ADA reach parameters.
- Call buttons in cabs appear to fall within ADA reach parameters.
- Elevator inspection reports since 1994 (attached).
- Elevator consultant report is attached.

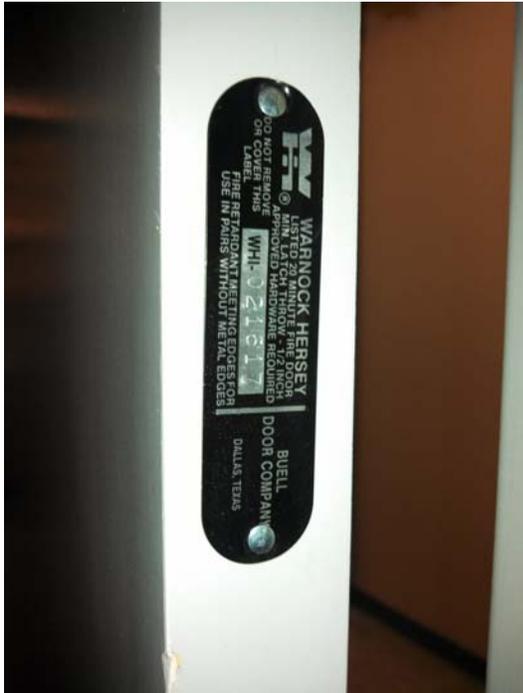
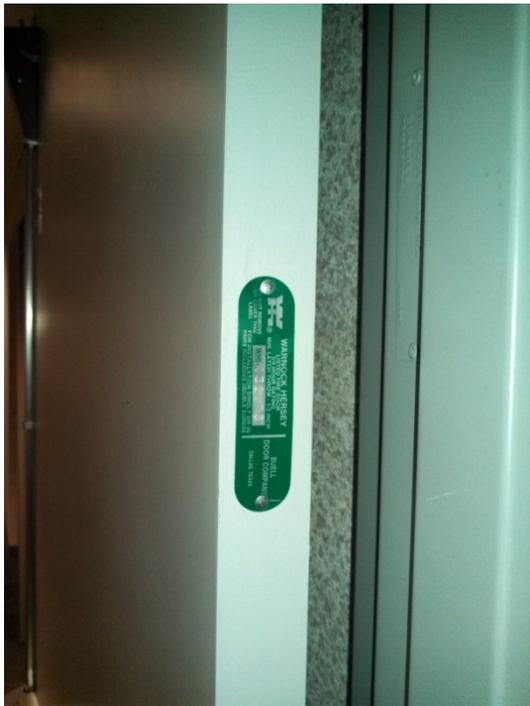
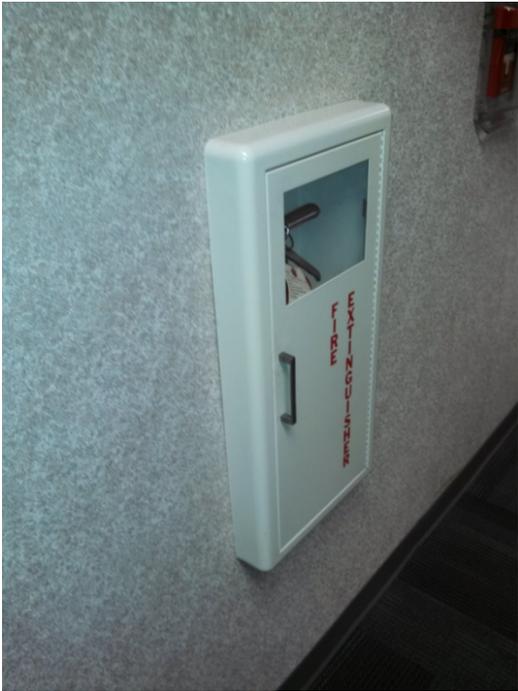
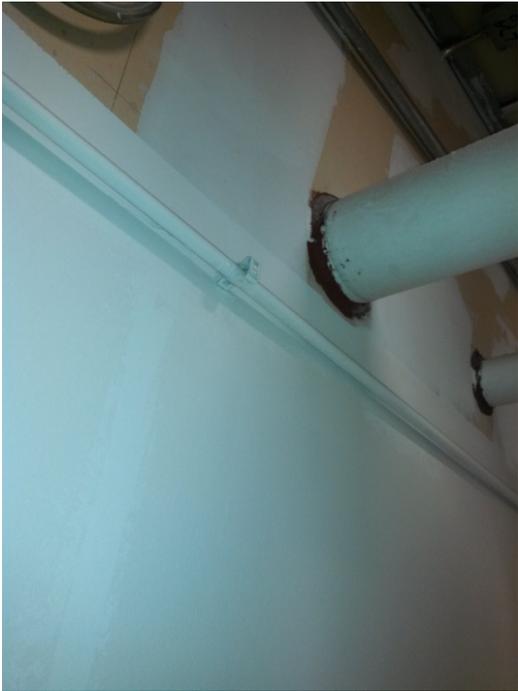
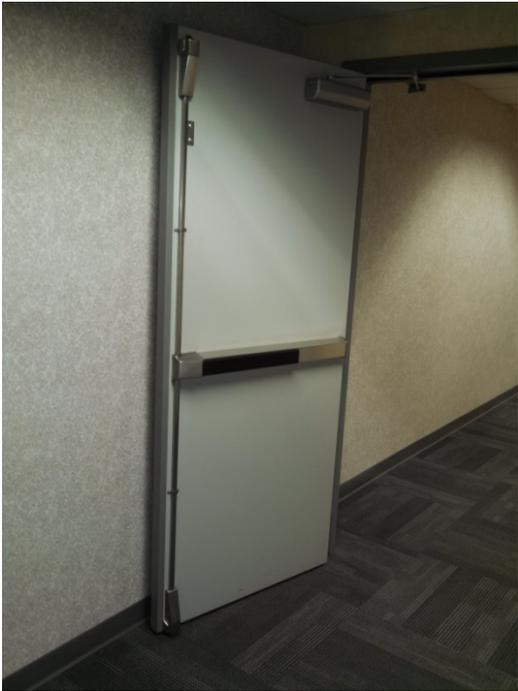
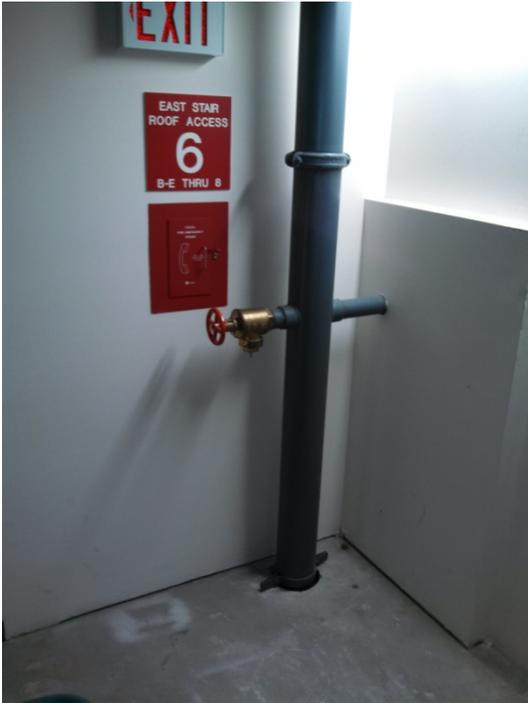
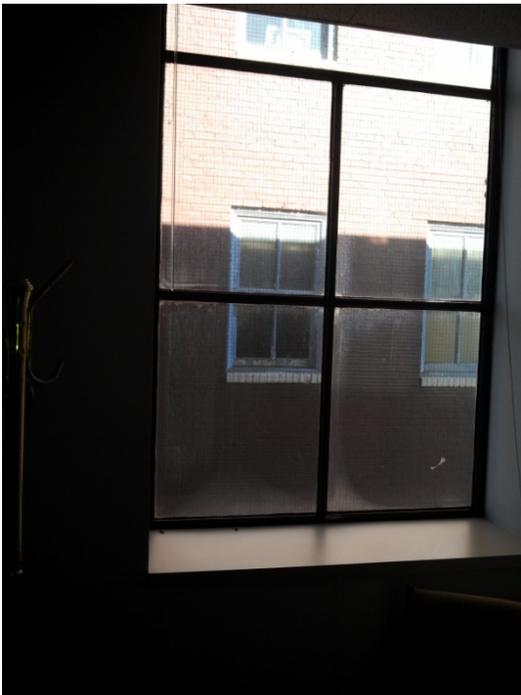
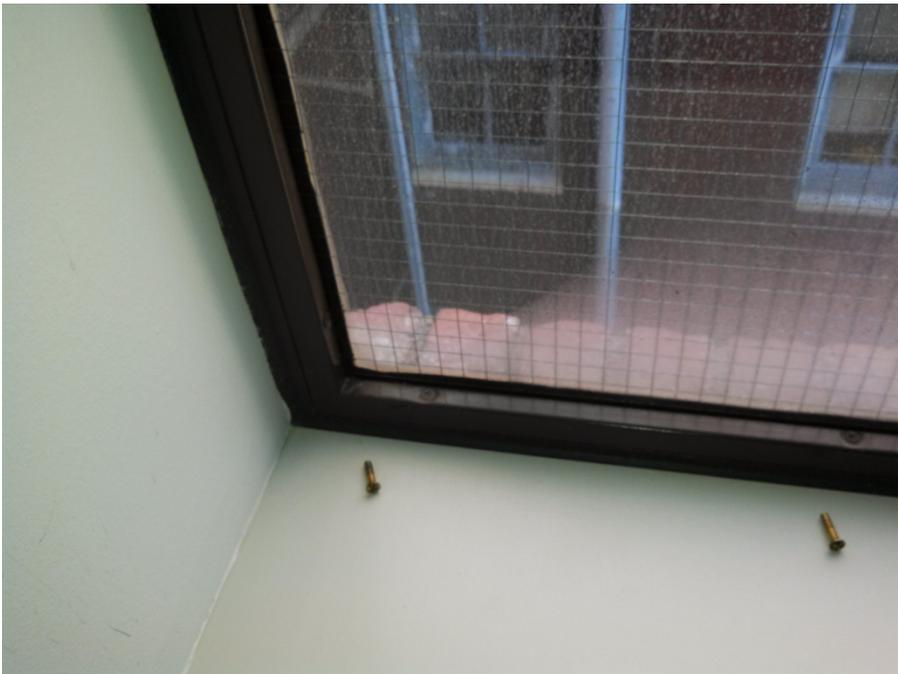
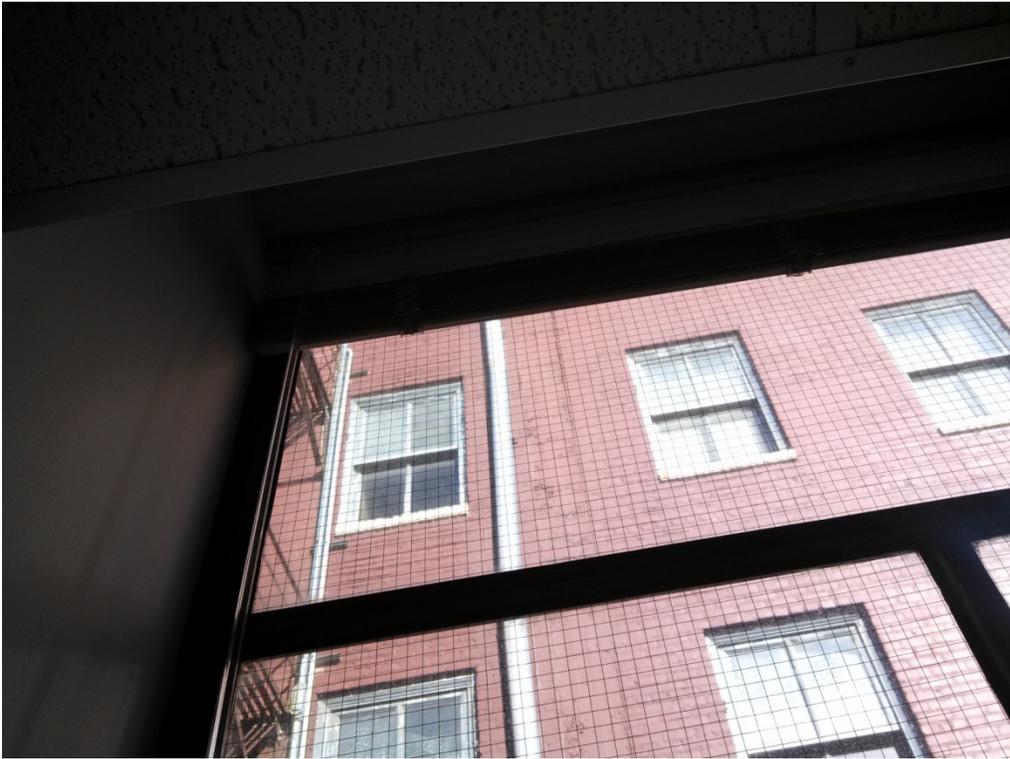
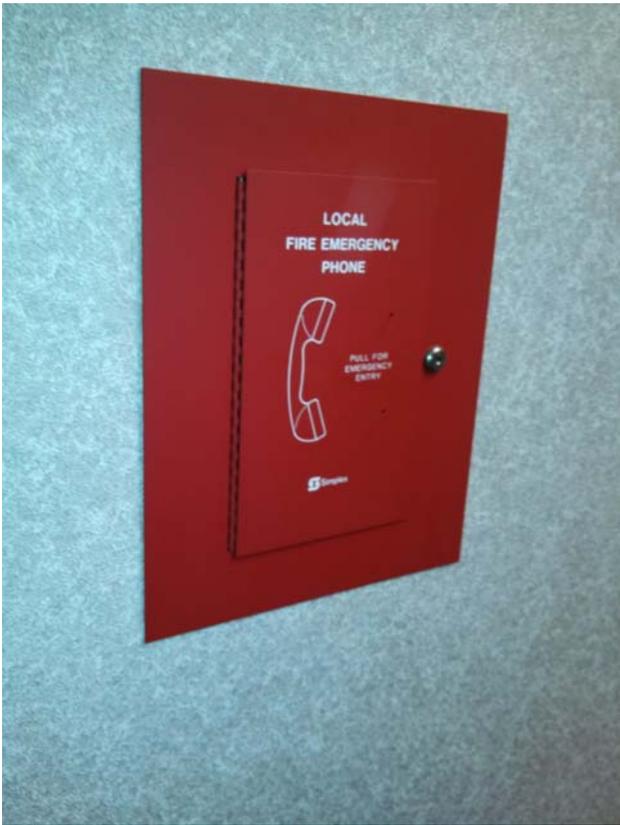
- Pull stations, extinguishers, etc. (see Life Safety Plan Exhibit).
- Fire sealants observed at rated walls. No compromises observed.
- Wire glass in exterior windows that share common public space.
- The entire building is equipped with a fire alarm and fire sprinkler system.
- Rated corridors were equipped with rated doors and closers.
- Exit signs appeared to be operational and properly placed.
- Chillers are equipped with emergency shutdown switch.

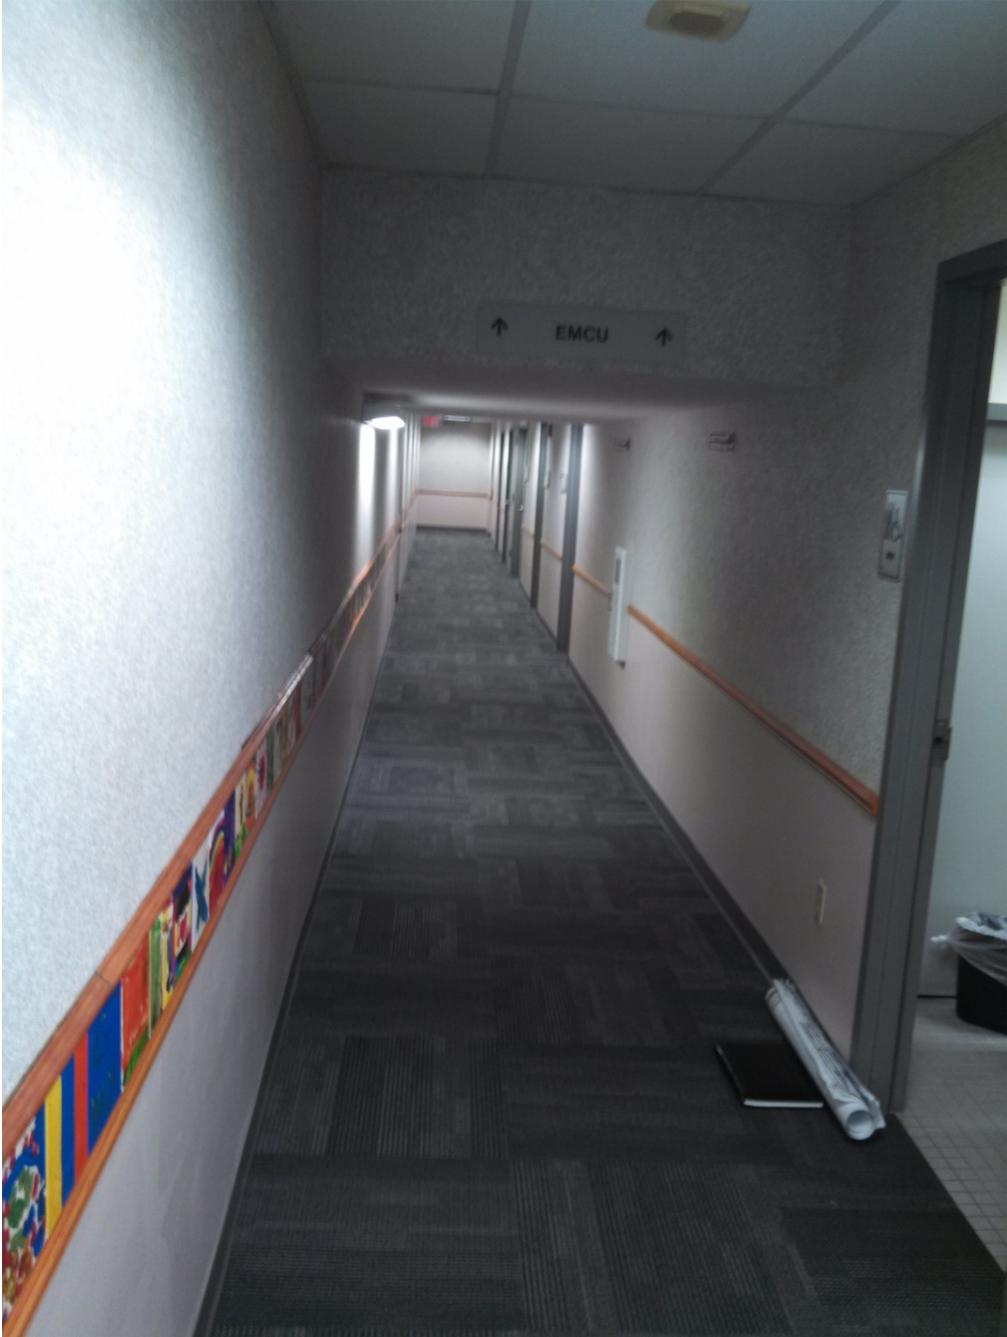
Code Violations

In the basement corridor that connects the west and east buildings, the head clearance is reduced to approximately 6'-2" (varies) for a distance of 18' as the corridor crosses what was once the alley above. The cause of the head clearance encroachment is undetermined. It is likely cost prohibitive or perhaps impossible to rectify the code violation. However, before a final evaluation or recommendation can be made, destructive investigation to determine the cause and potential solutions is recommended.

We found several of the elevators running at inconsistent speeds as compared to the contract speed. This indicates a potential problem being covered up or just lack of attention. As an example, Elevator 4 is operating at an average speed of 288 feet per minute (fpm), Elevator 5 is operating at 336 fpm, and Elevator 6 is operating at 266 fpm. Elevator code requires that the elevators be within +5 percent of contract speed. If not, the governors should be recalibrated to set the safeties at the correct tripping speed.
