**STATE OFFICE BUILDING
BUILDING ASSESSMENT
WICHITA, KANSAS**

GLMV PROJECT 13052.000

December 16, 2013

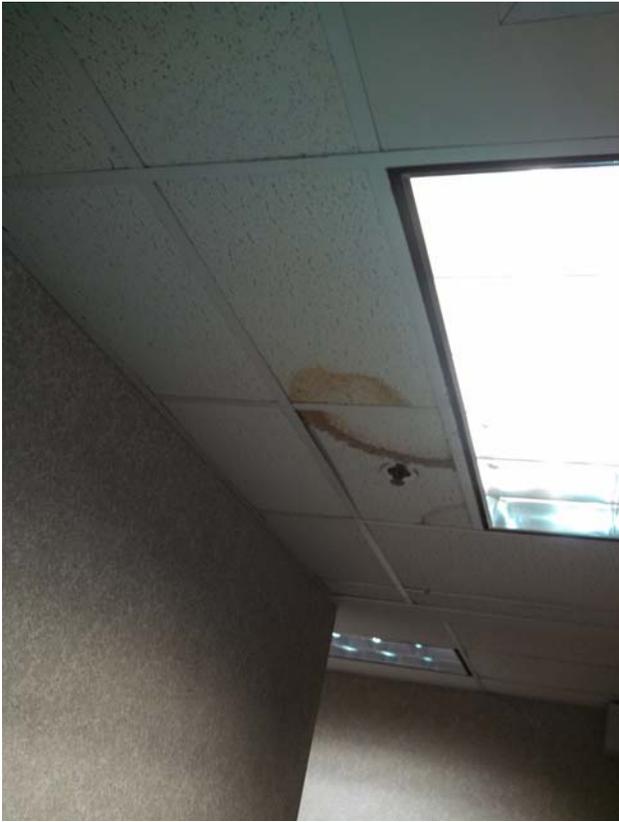
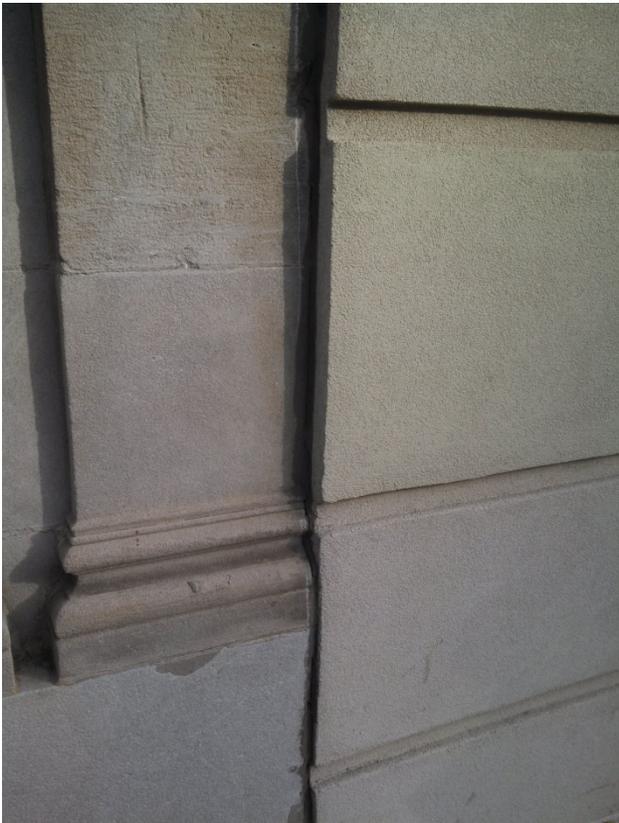
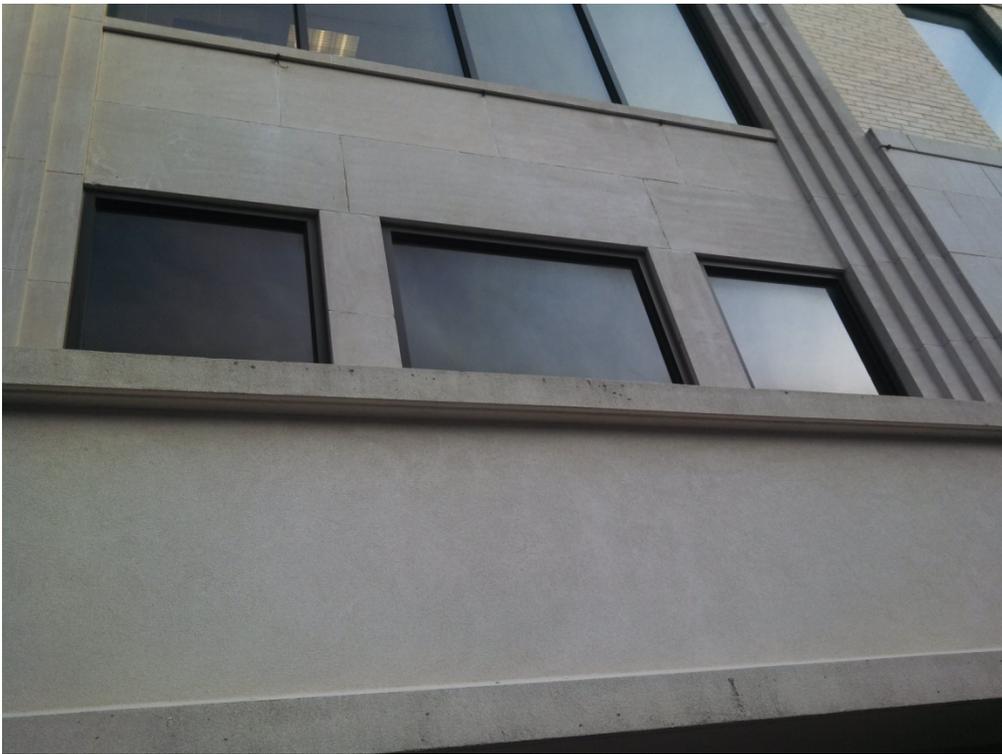
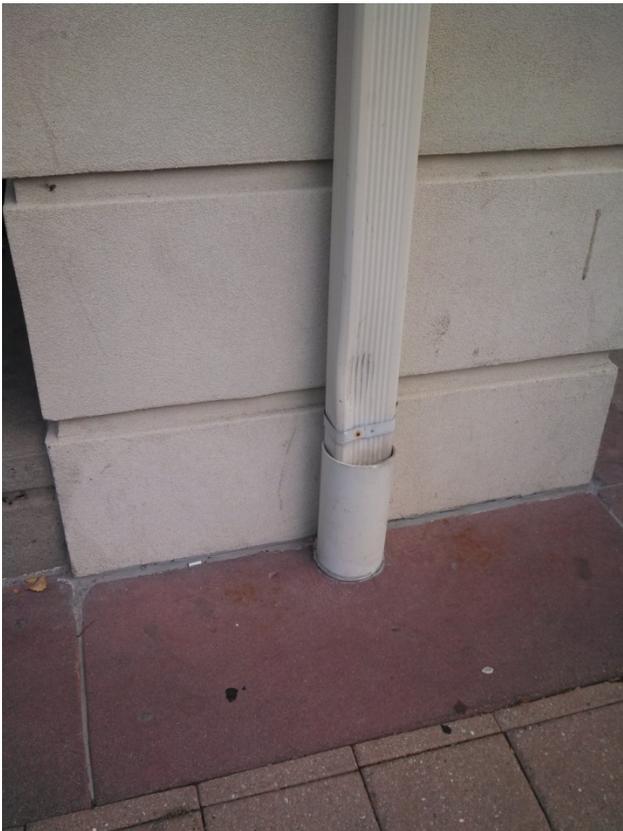
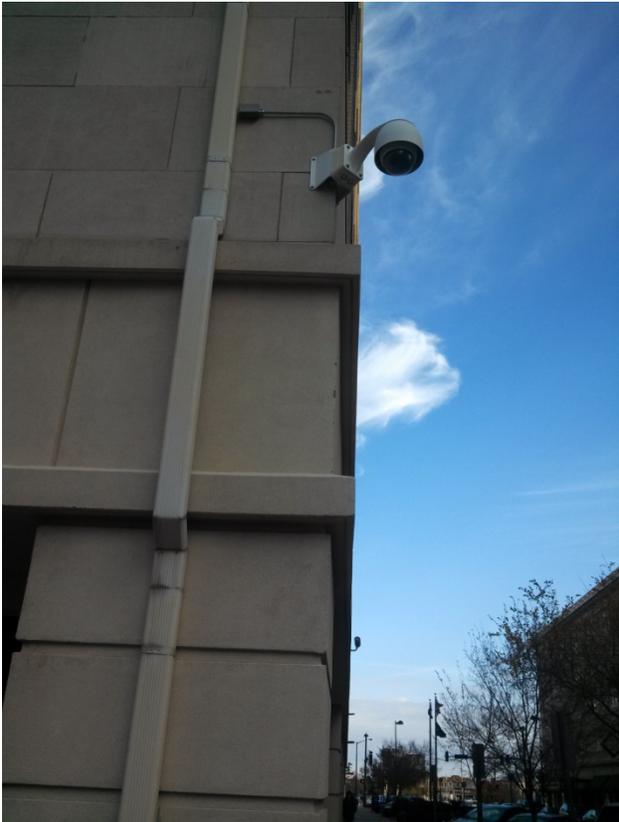
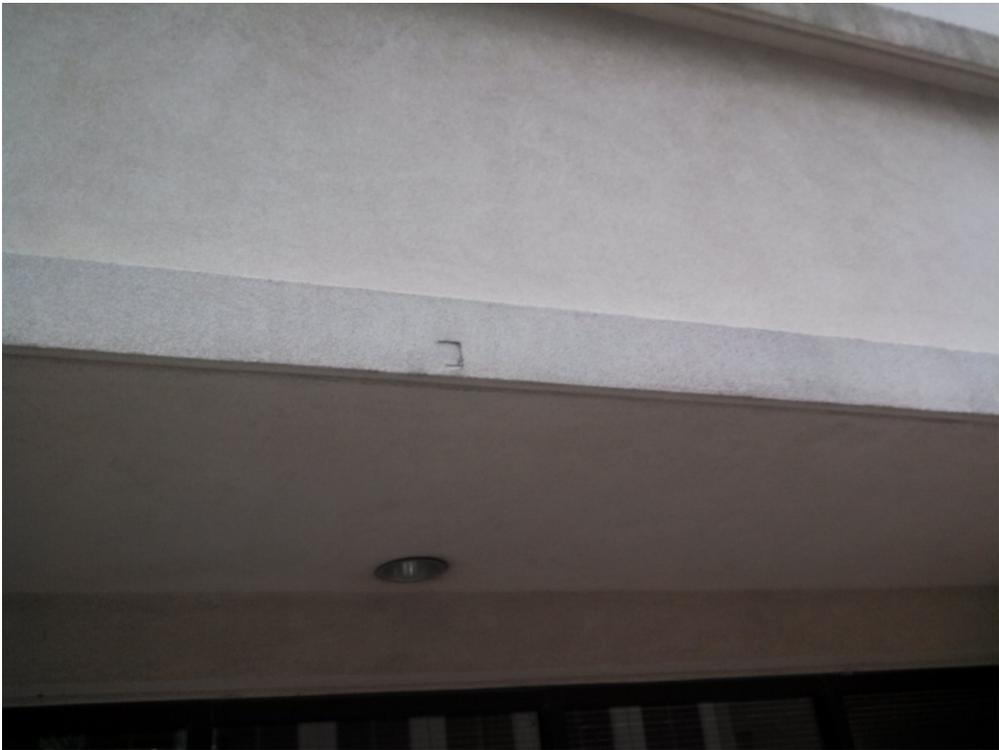
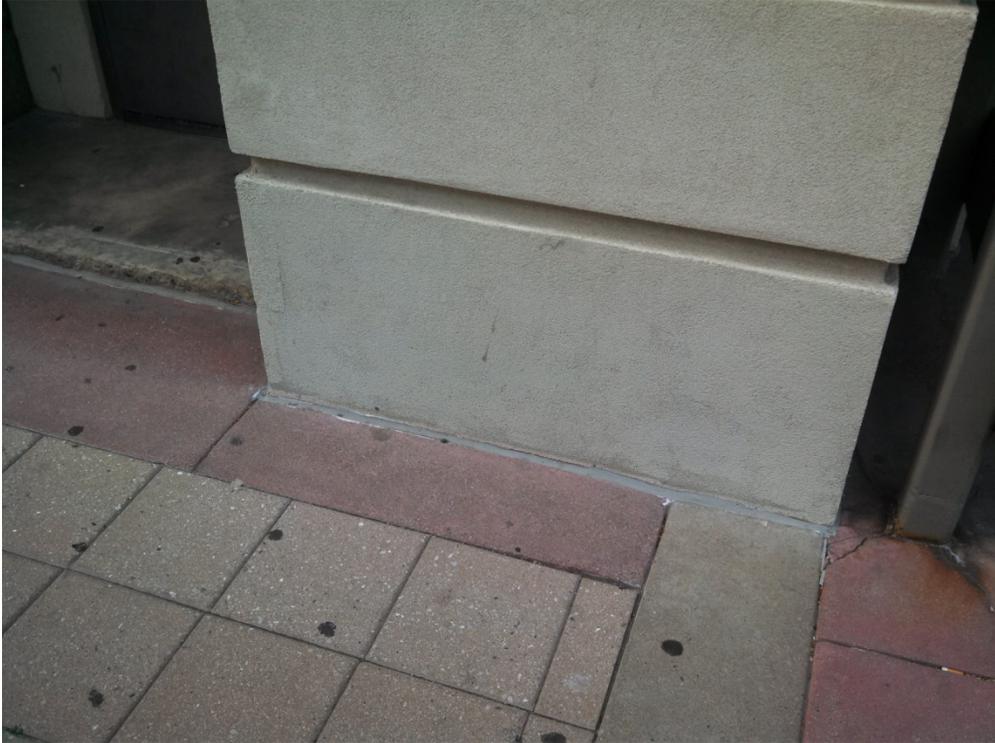
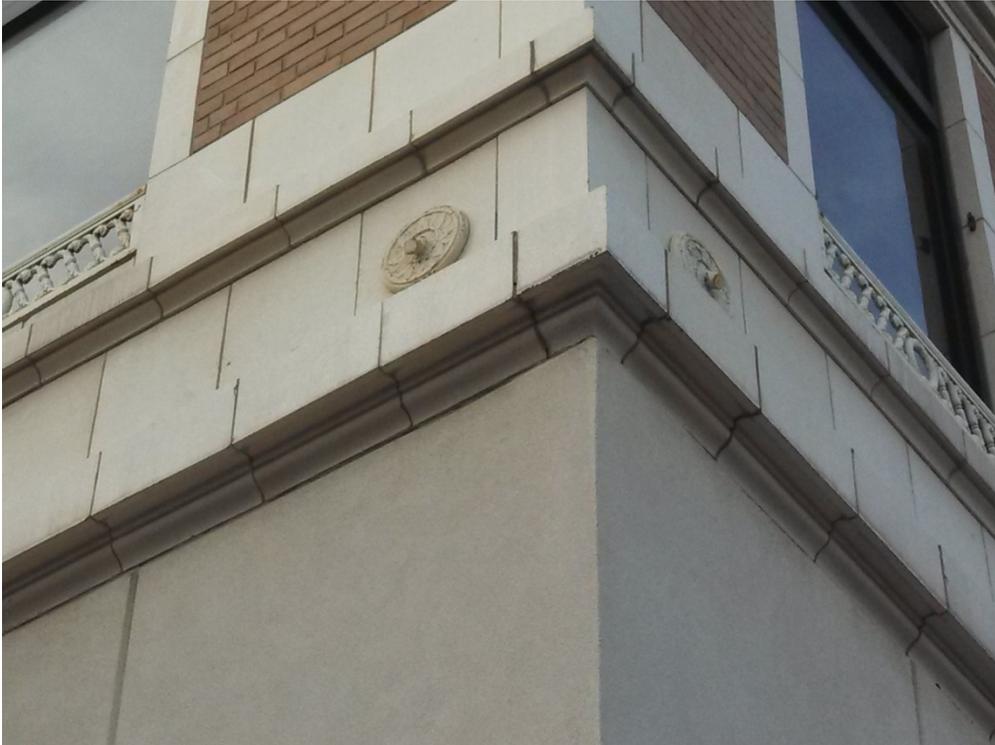
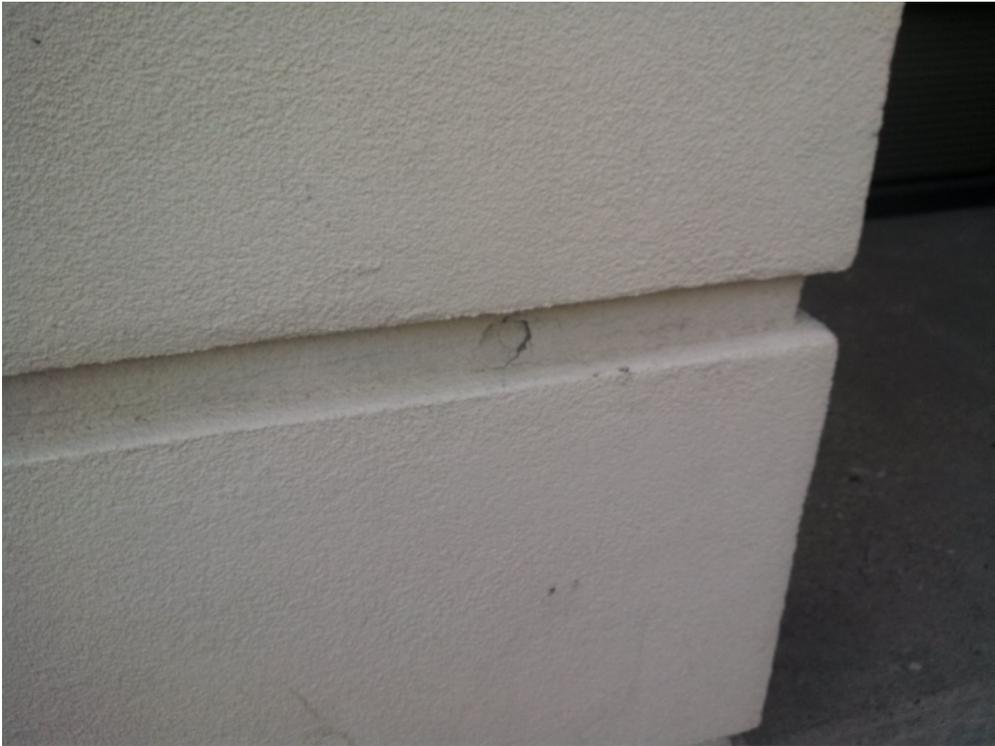
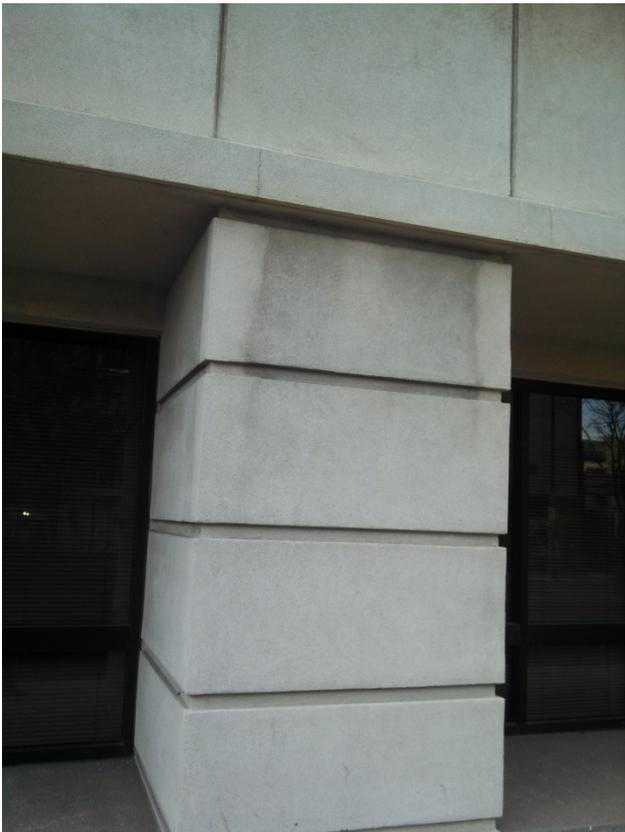
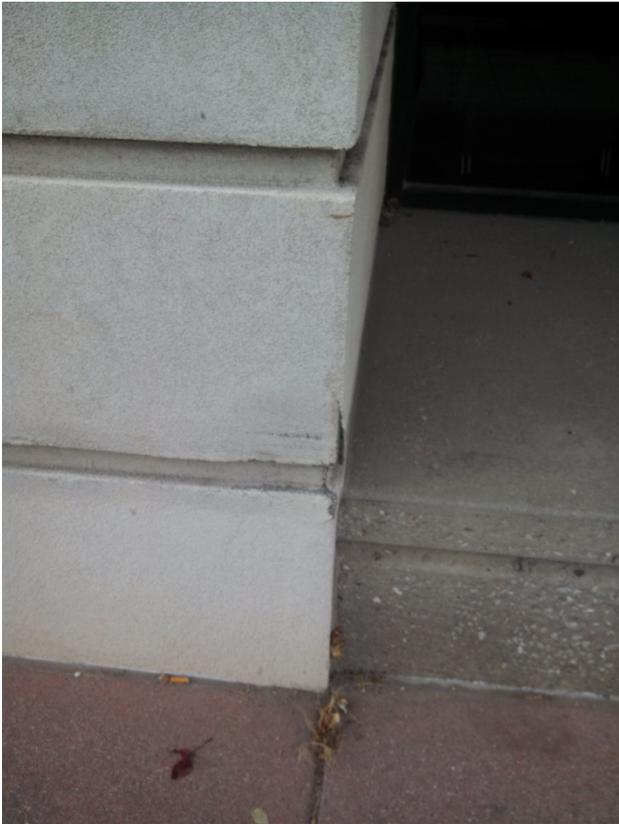
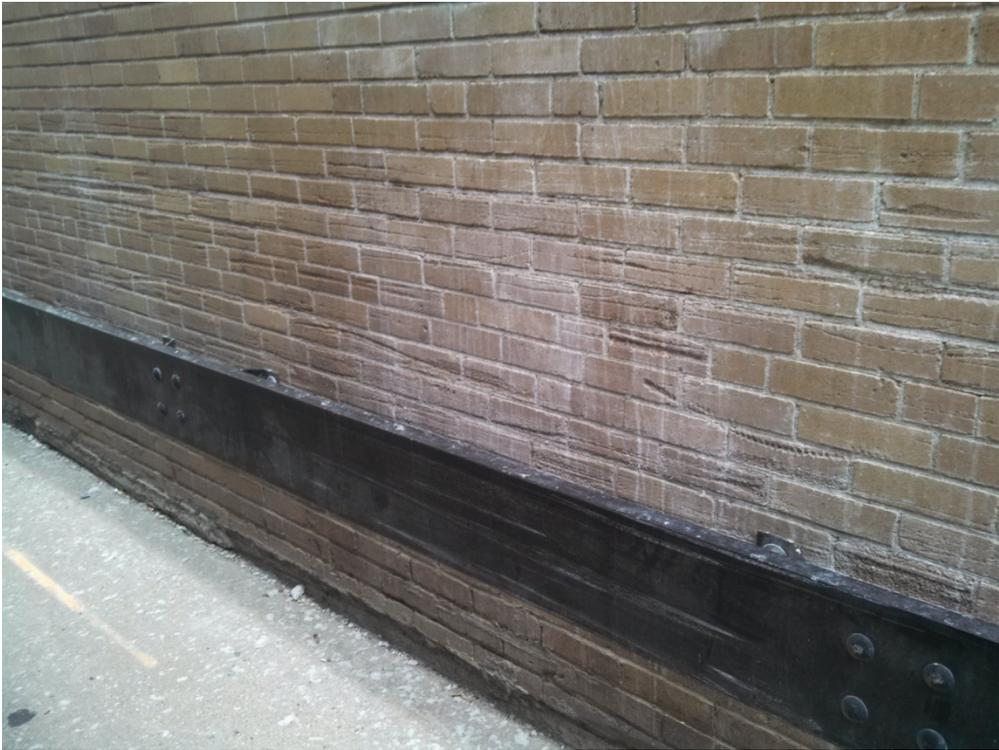
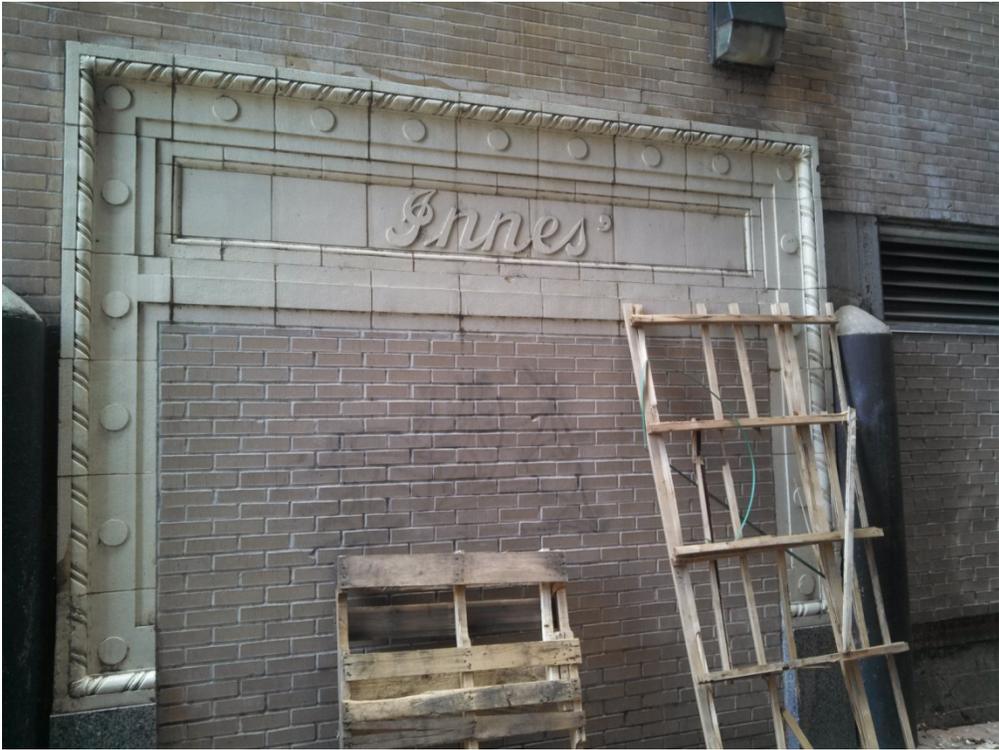
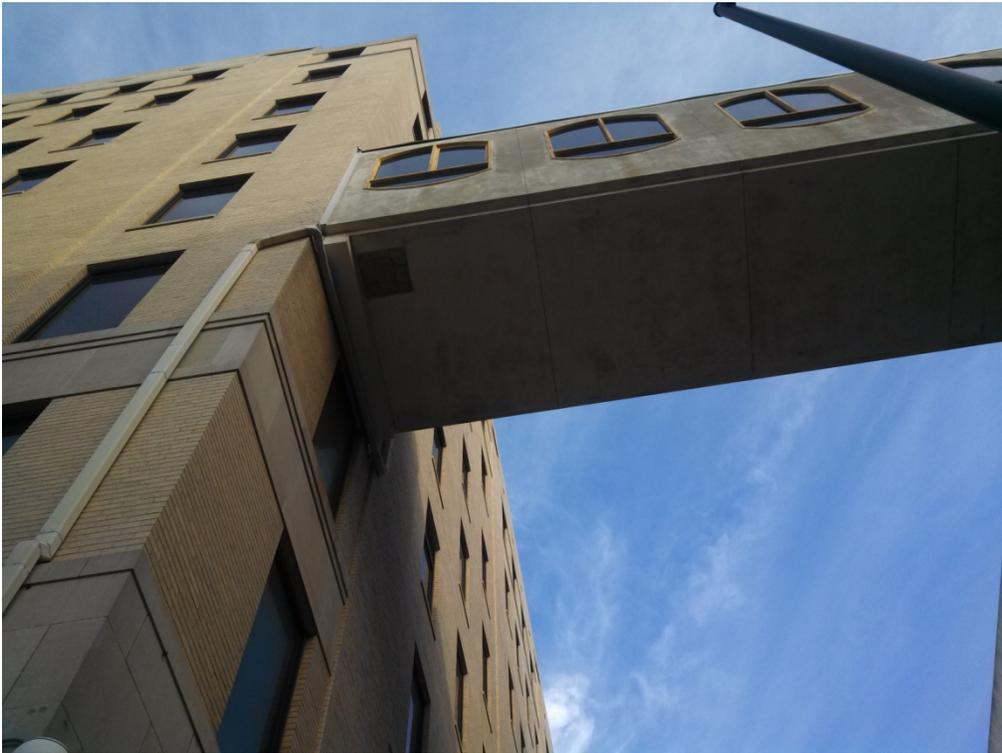
Building Maintenance Concerns

- There were a few observations of water-stained ceiling tiles and wall surfaces. These observations were discussed with the facility manager, Charles Jacobs, and were noted as being rectified. There are no known roof or plumbing leaks at the time of this assessment.

- Periodic exterior and interior mortar inspection, repair, and tuck-pointing are anticipated as routine maintenance items due to the age of the building brick and limestone structure and veneer. Extensive tuck-pointing has recently been accomplished on the north side of the east building. Mortar restoration and tuck-pointing should be anticipated on the west, south, and east exterior brick and limestone in the near future.

- High-traffic areas around elevators show higher than average wear. Recarpeting of these areas should be considered in the near future.
- Signs of past graffiti were observed on the alley side of the building. This type of activity is likely to be an ongoing concern.

- Some of the elevator motors are about 80 years old. They may require a higher amount of maintenance due to their age.
- Street-level EIFS will likely incur dings, dents, and superficial damage due to its location.

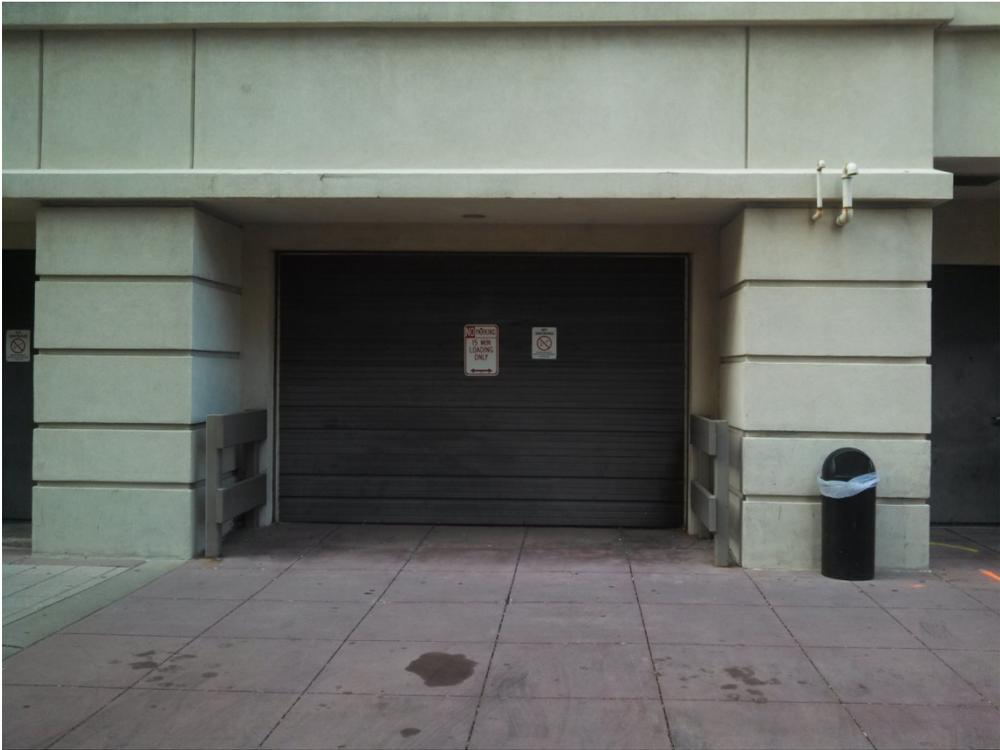
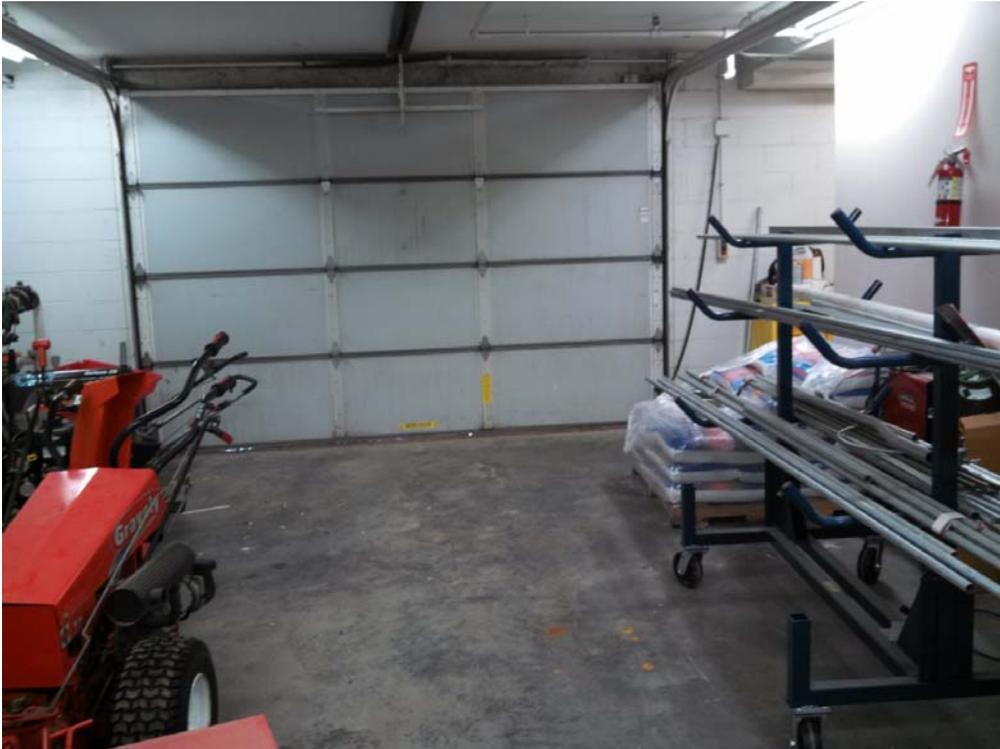
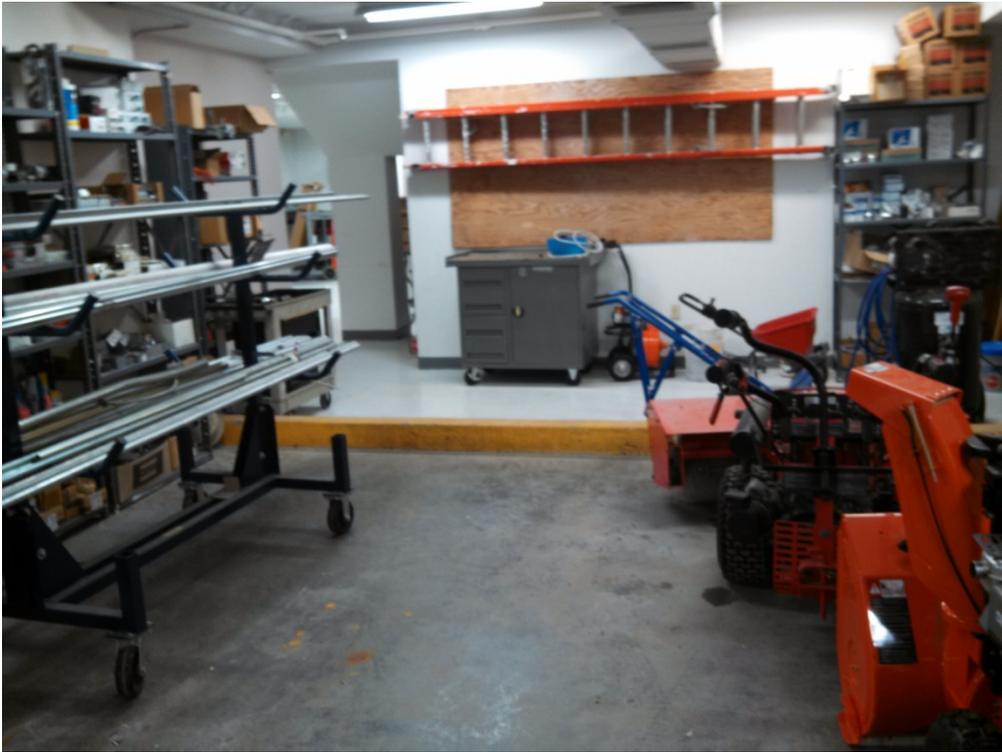
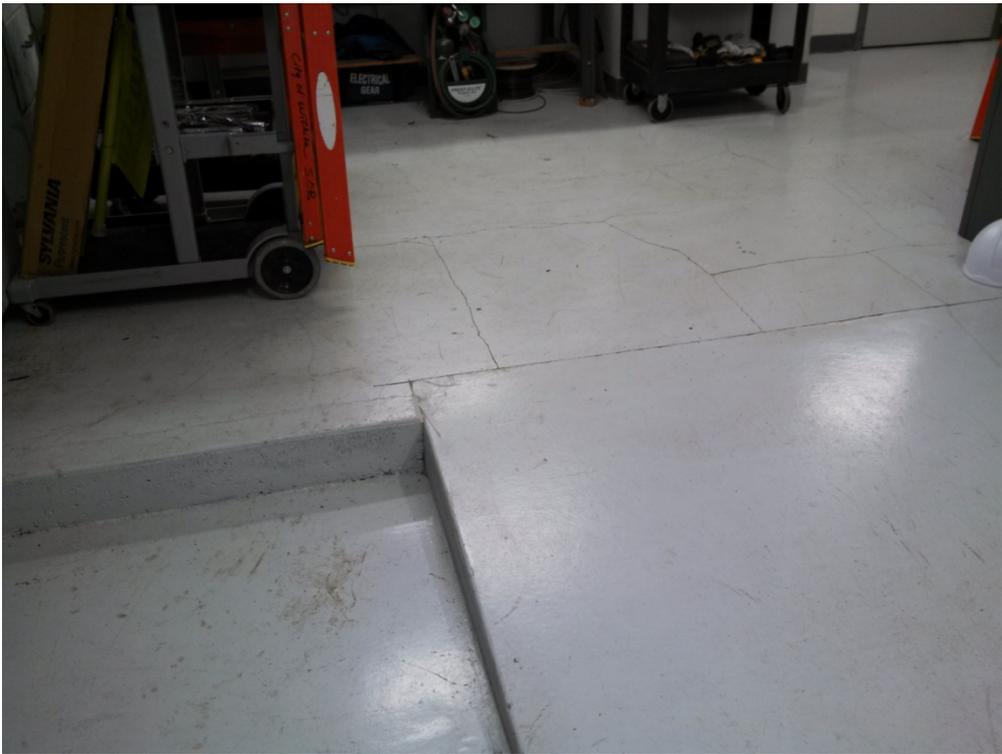
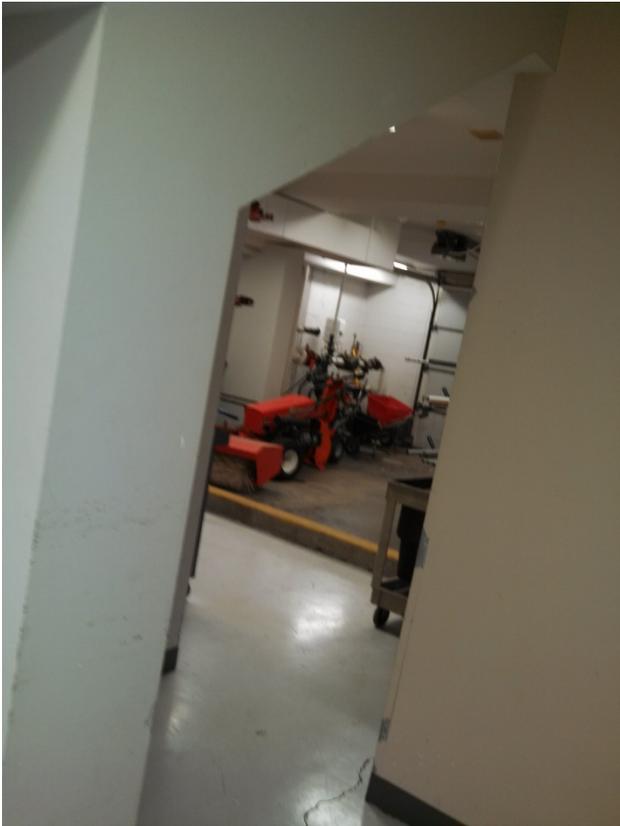
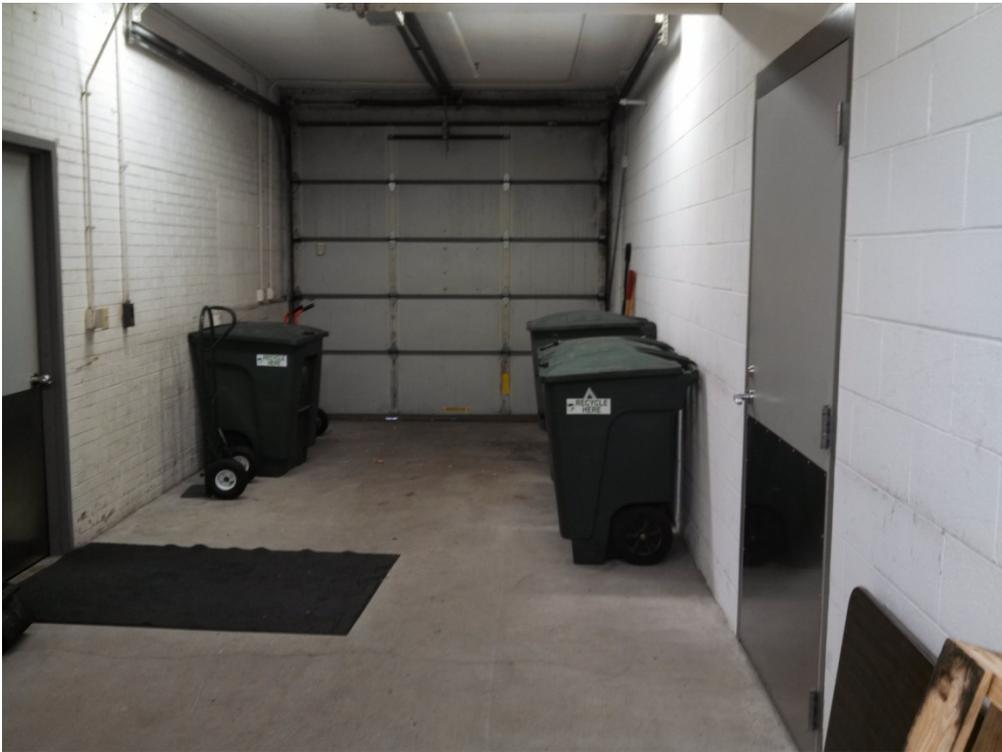
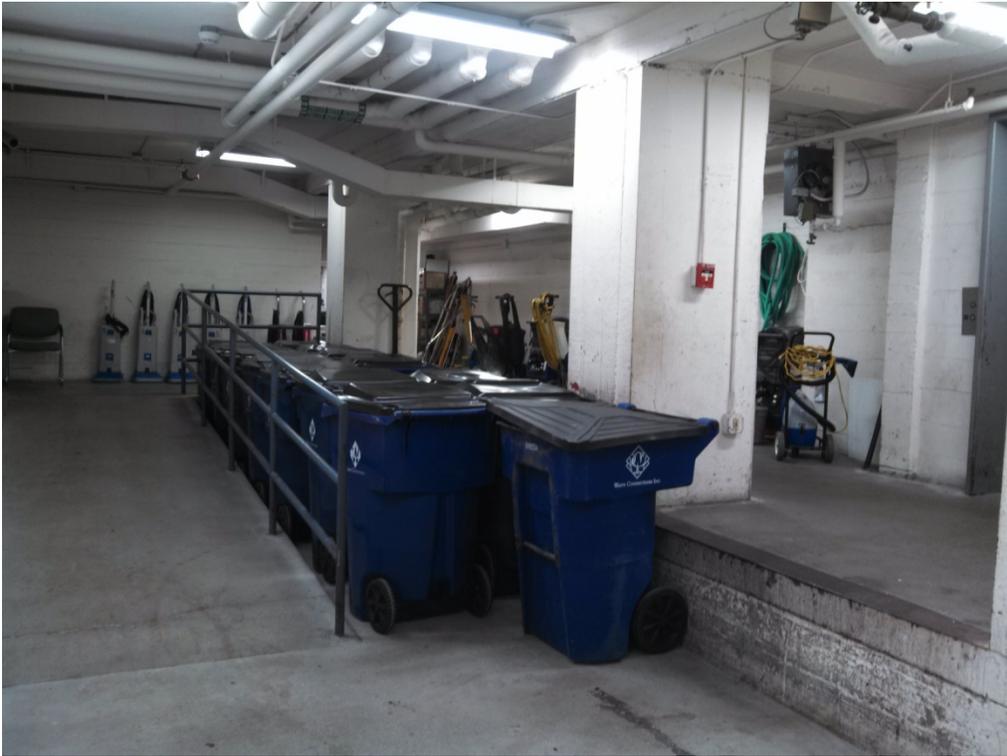
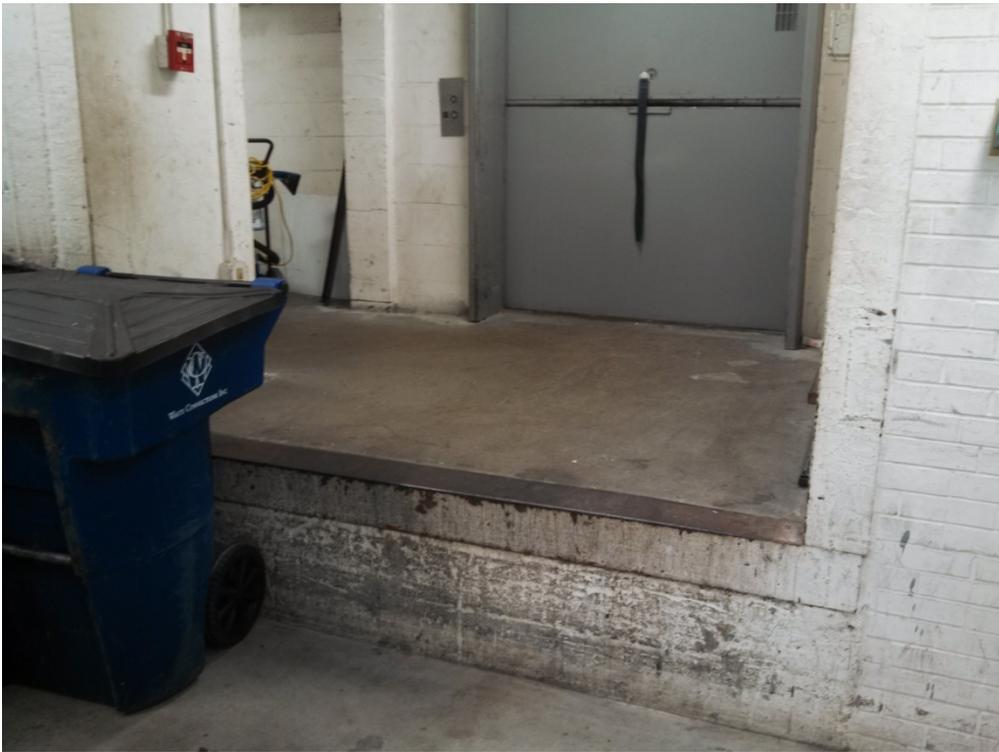
Trash Loading Maintenance

- Trash collection area for the building is centrally located on the first floor (street level).
- Trash removal is through an overhead door facing William Street.
- The area of trash accumulation for the entire building is limited, necessitating a daily trash service pickup.
- This point also provides a service delivery area for building tenants.

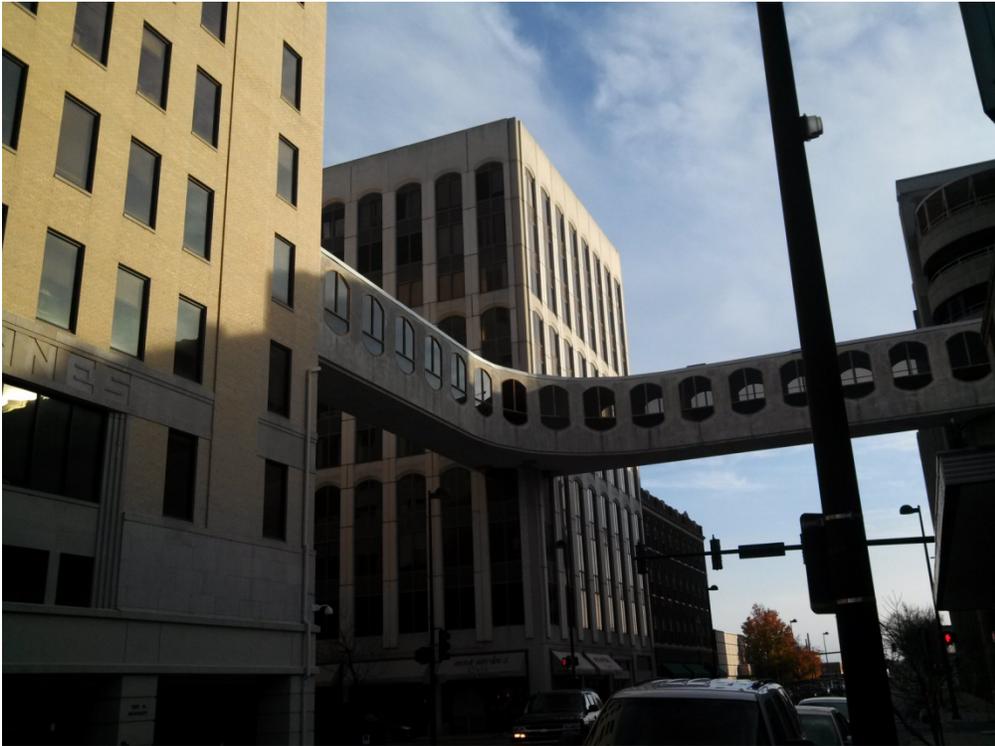
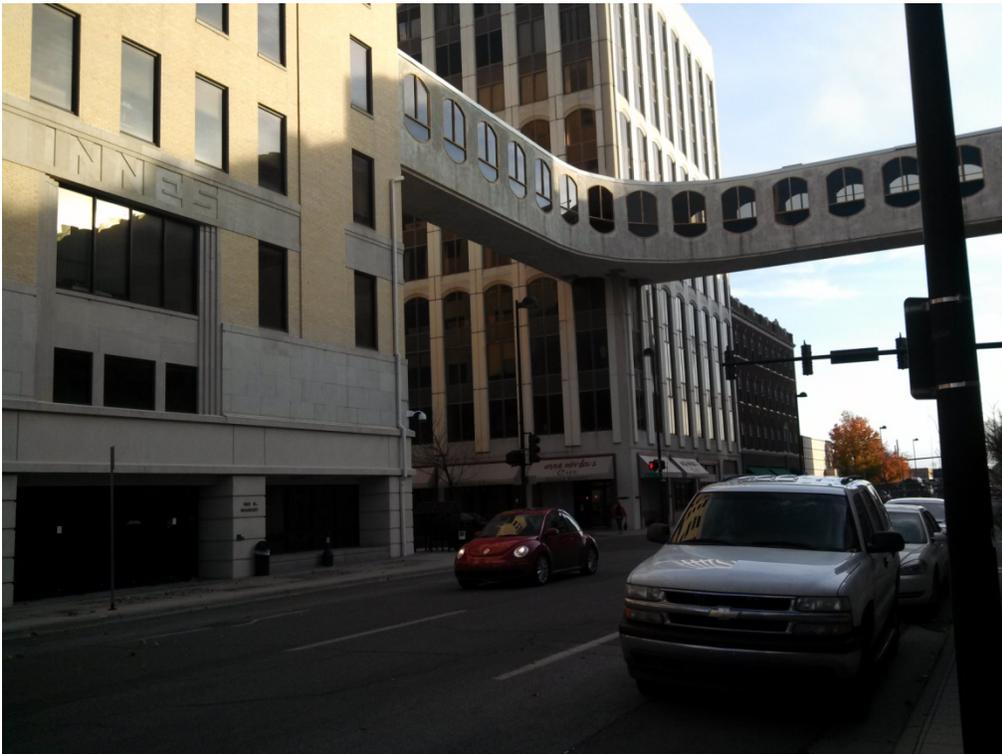
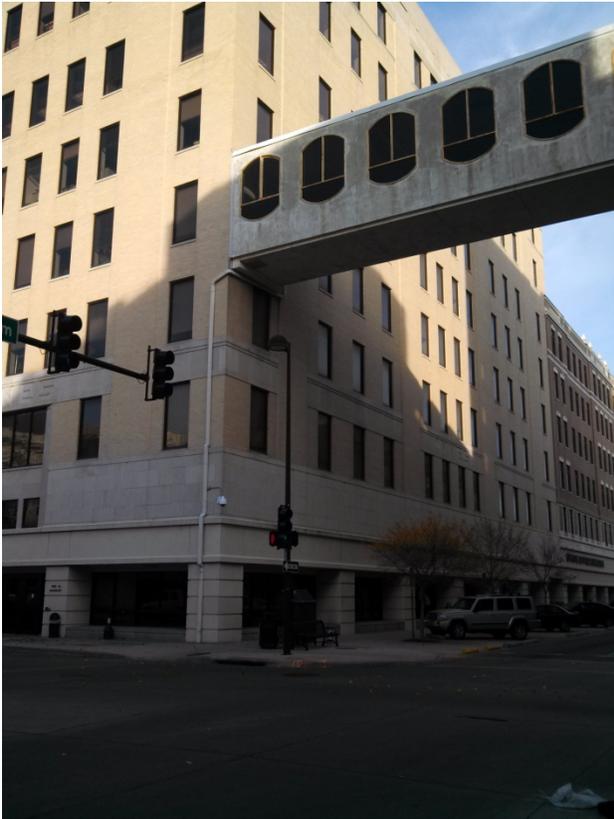
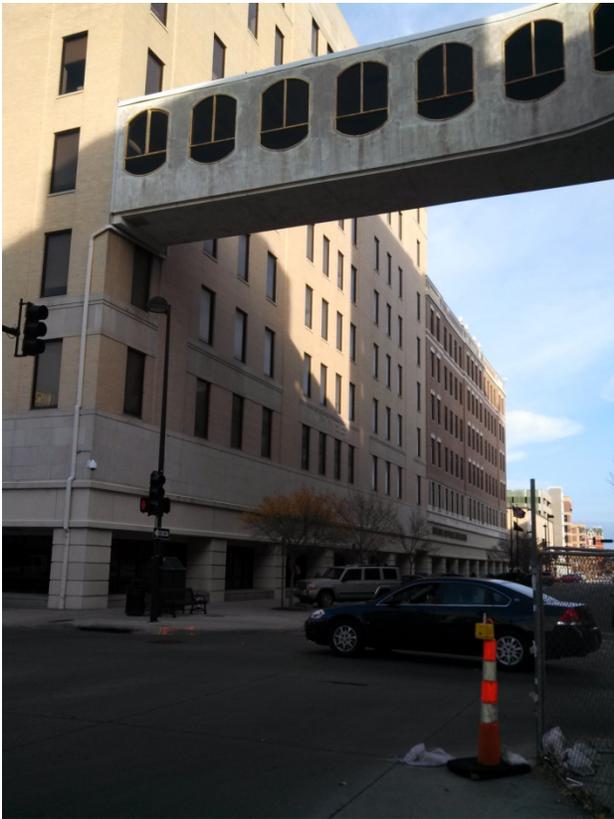
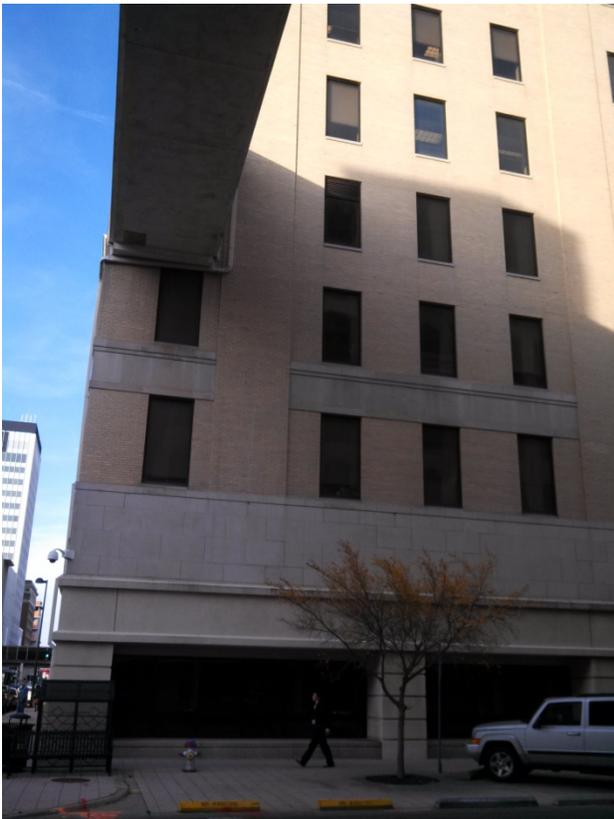
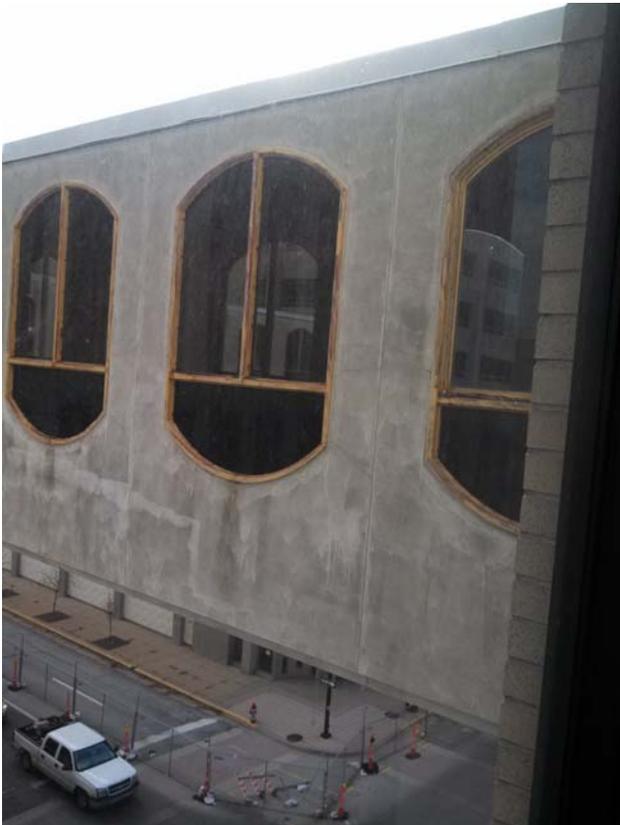
Skywalk

A fourth floor skywalk connects the southwest corner of the building to a parking garage diagonally across the street. The skywalk appears from the outside to be unmaintained with exterior cleaning, paint of window trim, and crack repair as a minimum maintenance concern. The interior of the walk was not observed.

Ownership of the skywalk and with whom maintenance responsibilities lie is not determined.
