**STATE OFFICE BUILDING
BUILDING ASSESSMENT
WICHITA, KANSAS**

GLMV PROJECT 13052.000

December 16, 2013

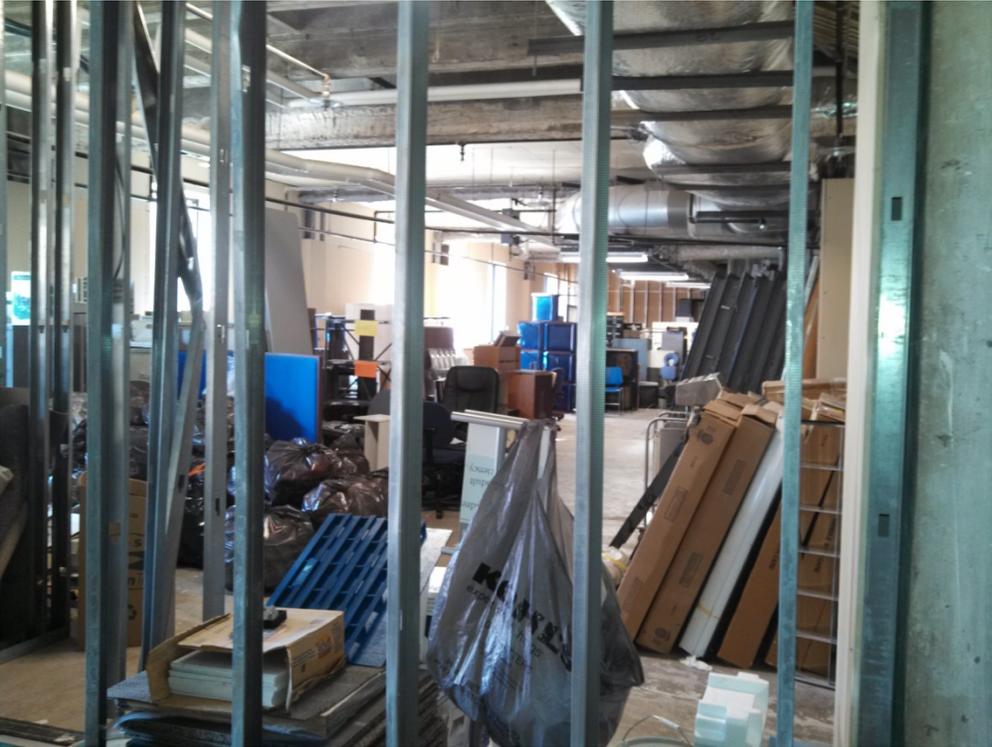
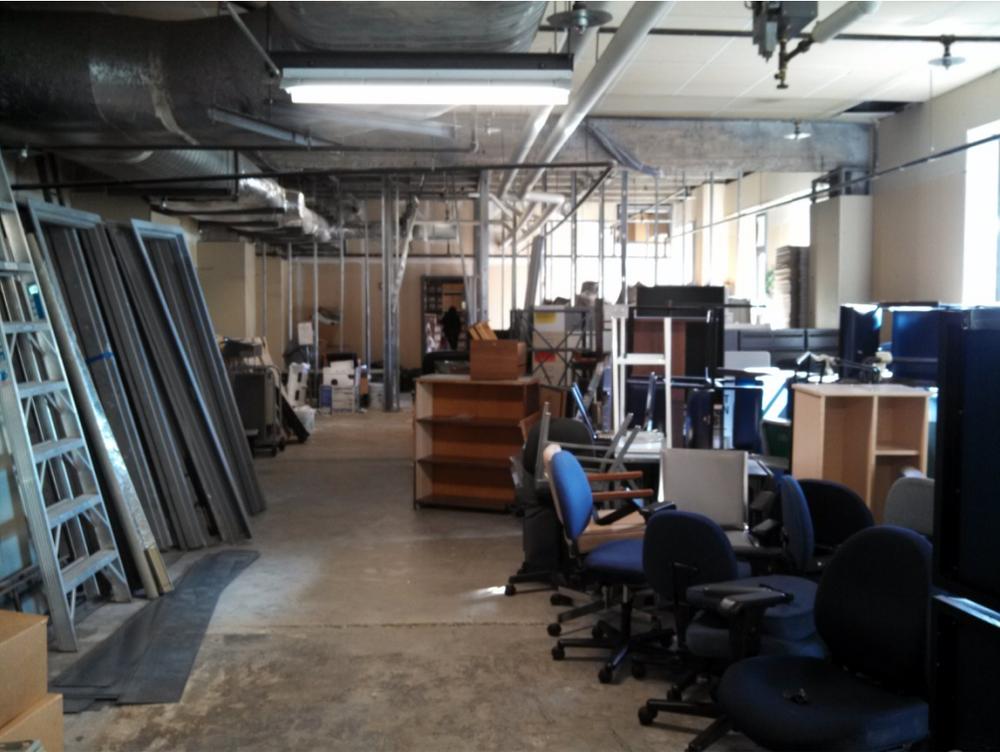
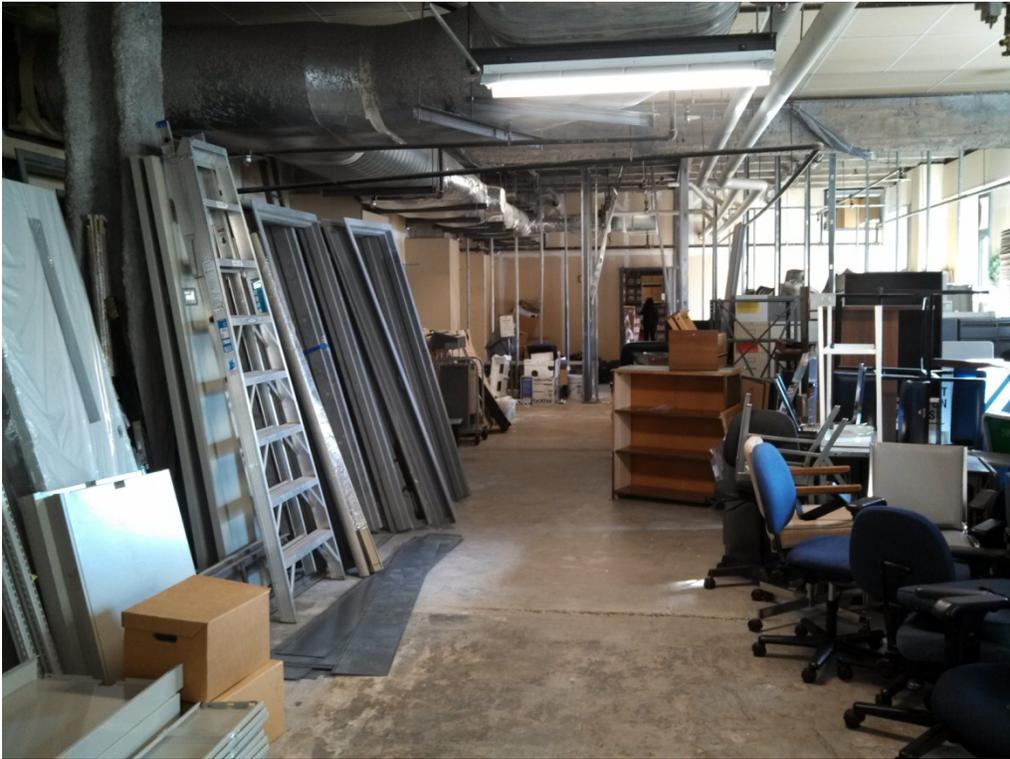
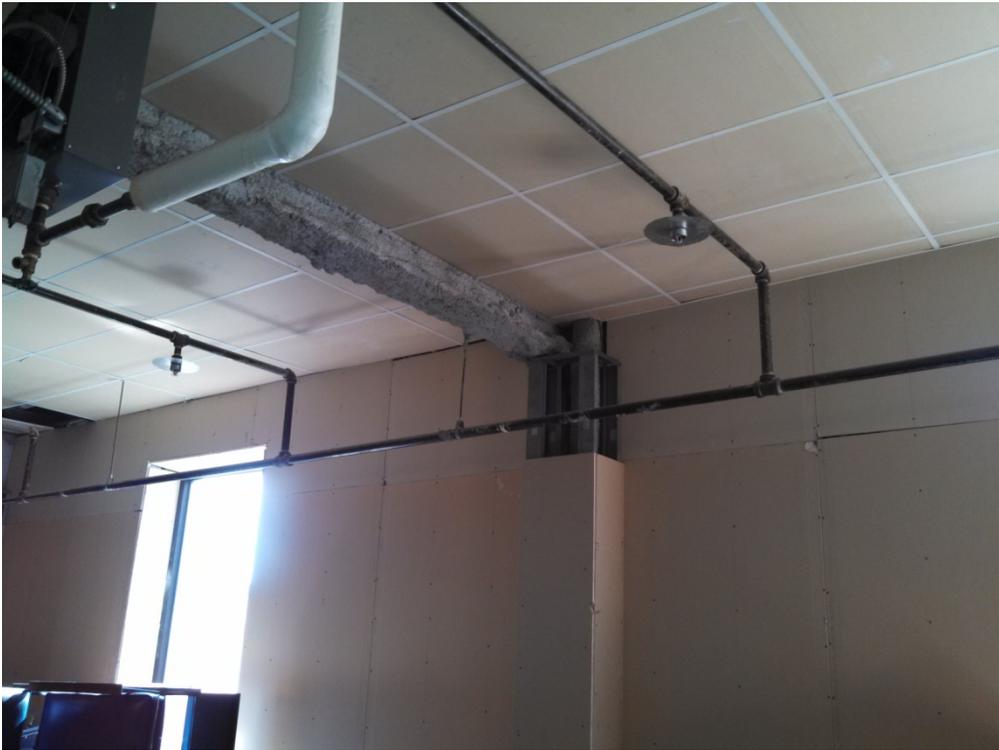
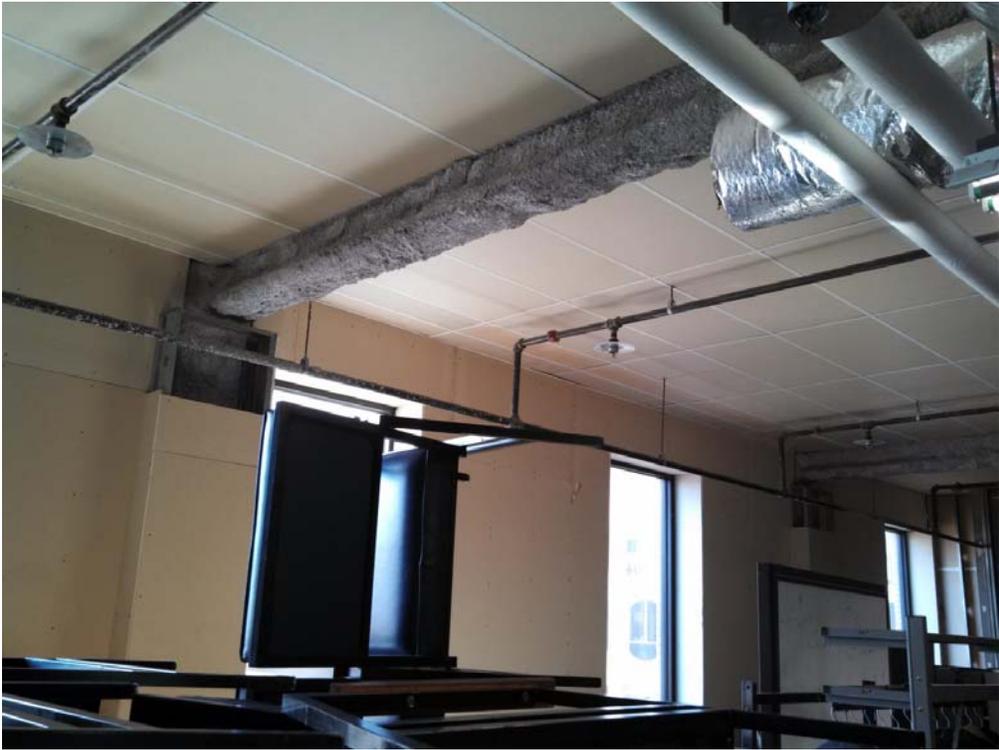
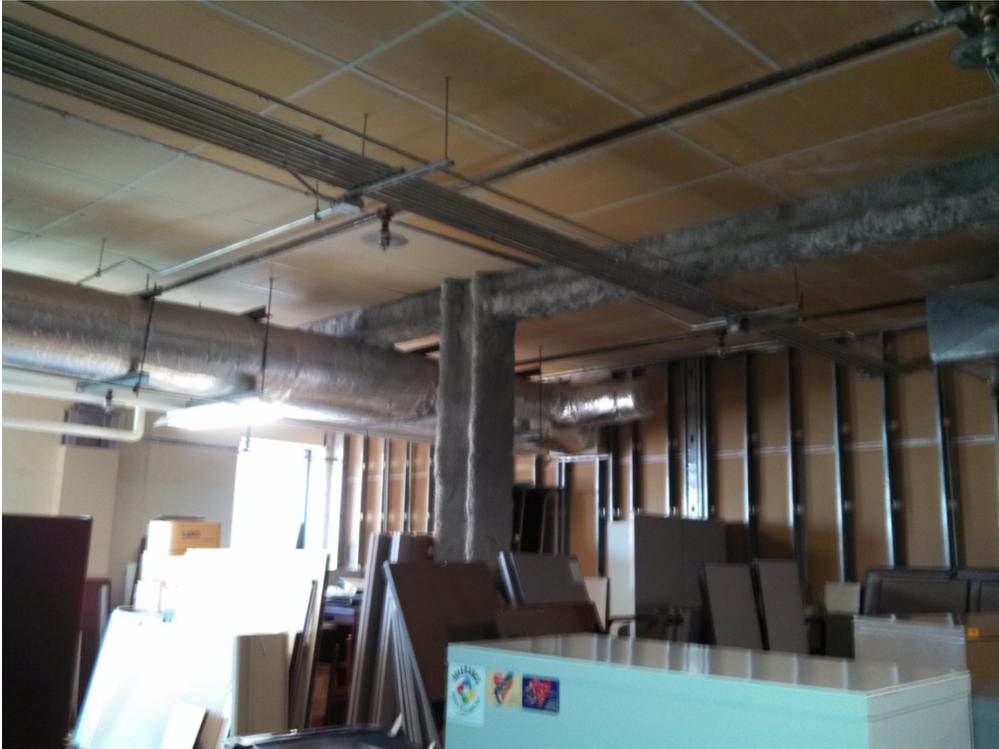
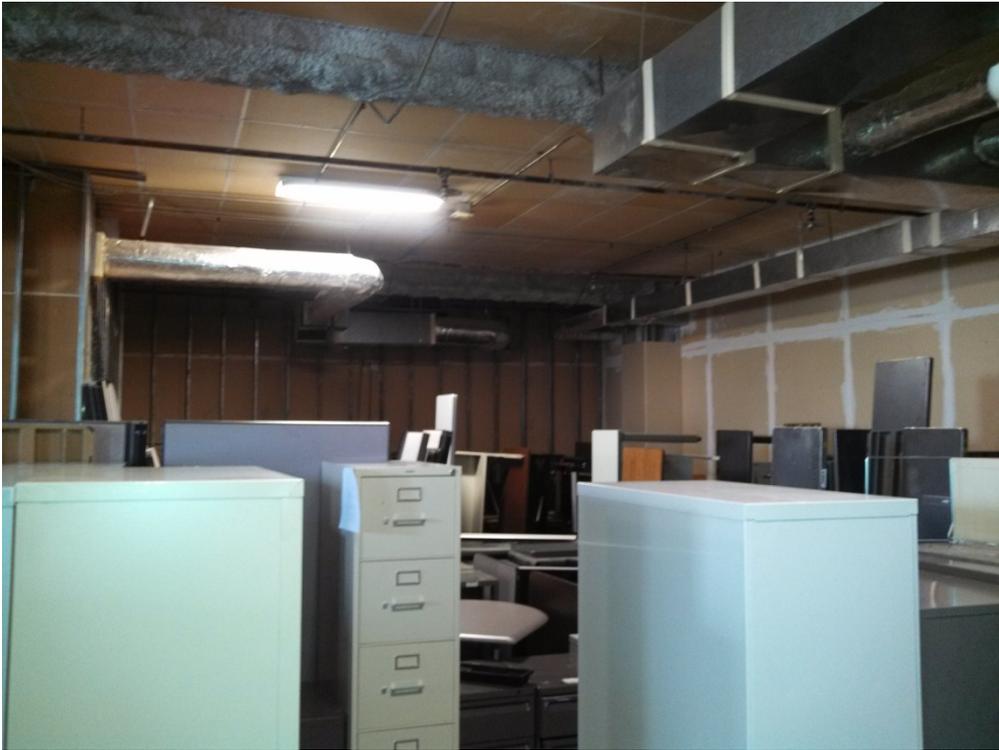
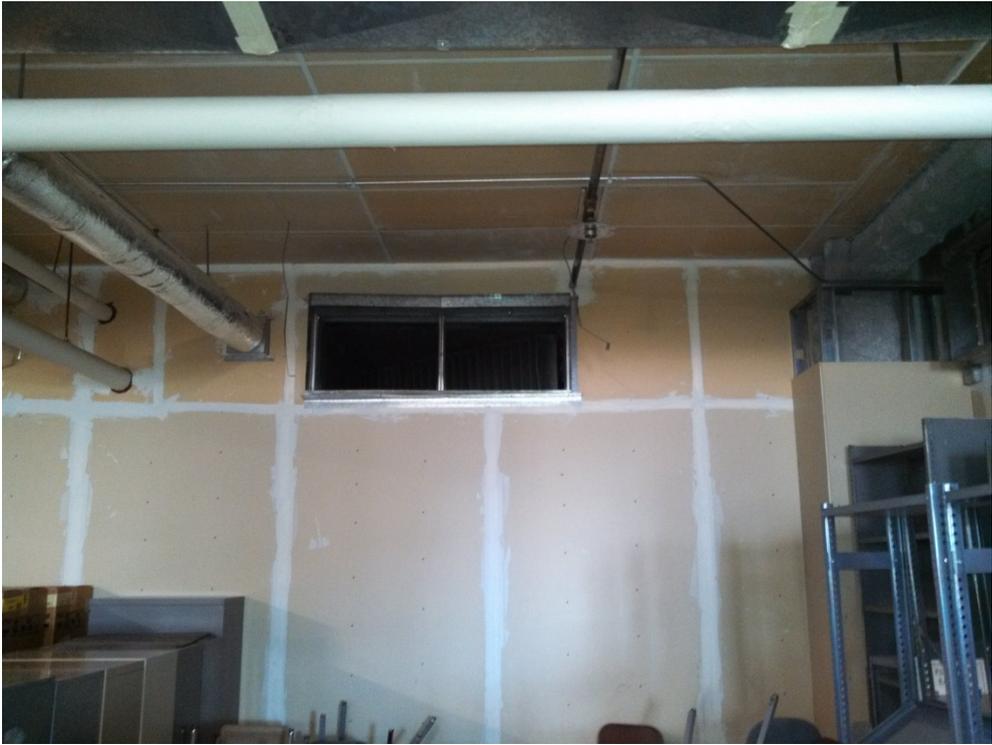
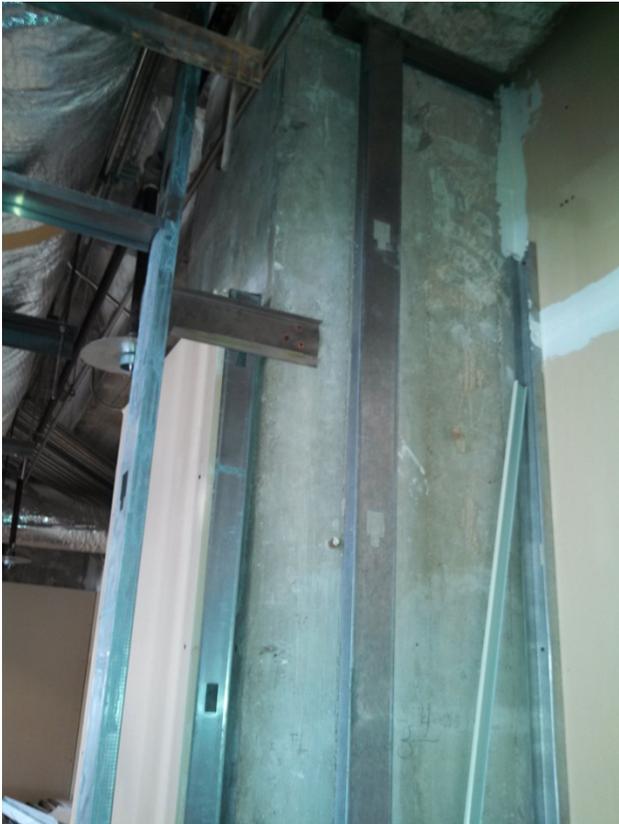
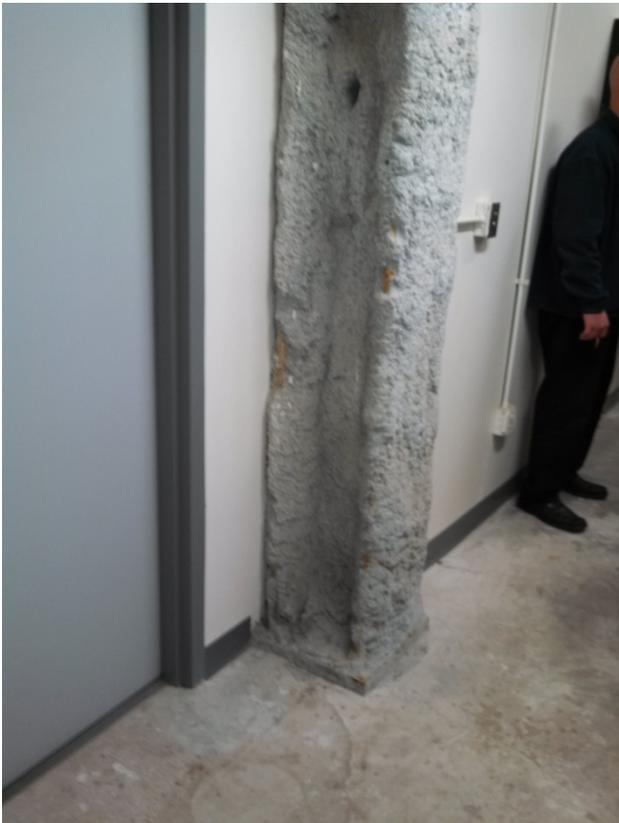
Unfinished Space, Fourth Floor

- Unfinished space, fourth floor (photos attached).
- Unfinished space, eighth floor (photos attached)
- Dining assembly space configured to accommodate 185 persons in chairs only or 87 persons seated at tables with chairs (photos attached).
- Courtroom: Space currently configured to accommodate public meetings or courtroom setting (photos attached).
- Mechanical Mezzanine: Between the first and second floors is a mezzanine space used exclusively for mechanical systems (photos attached).

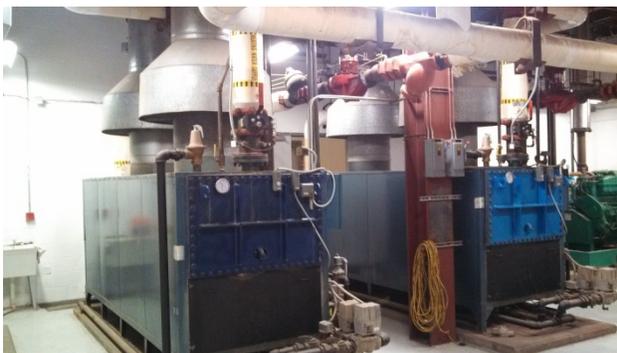
The heating plant for the building is comprised of two gas-fired, hot water boilers that are both located in the mechanical penthouse on the roof of the east building (see photo below).

The boilers are atmospheric, water tube units with nominal capacity of 7,500 MBH. ASHRAE lists the median service life of a boiler to be greater than 22 years. Coupled with the rebuild of the boiler in 2006, it is expected that there is still a significant service life associated with the units.

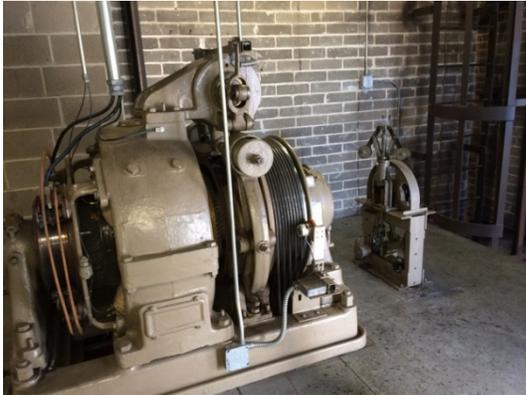
The Finney State Office Building, located at 130 S. Market and 230 E. William, has six passenger elevators and one freight elevator. The six passenger elevators are all gearless traction elevators with 1930s vintage Otis Elevator machines with early 1990s vintage Montgomery Elevator microprocessor controls. The freight elevator has an early 1990s vintage Hollister Whitney Elevator Corp. geared traction machine and early 1990s vintage Montgomery Elevator microprocessor controls.

Elevators 1 through 6, all with similar gearless machines

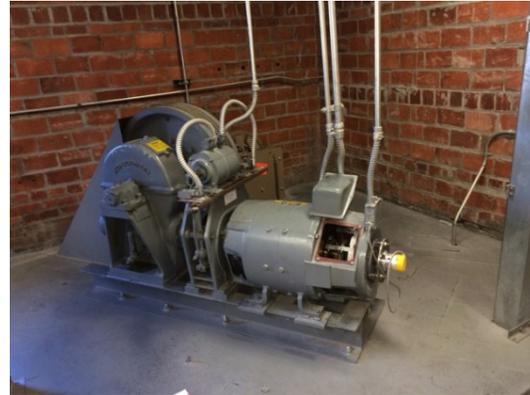
Elevator 7 with geared traction machine

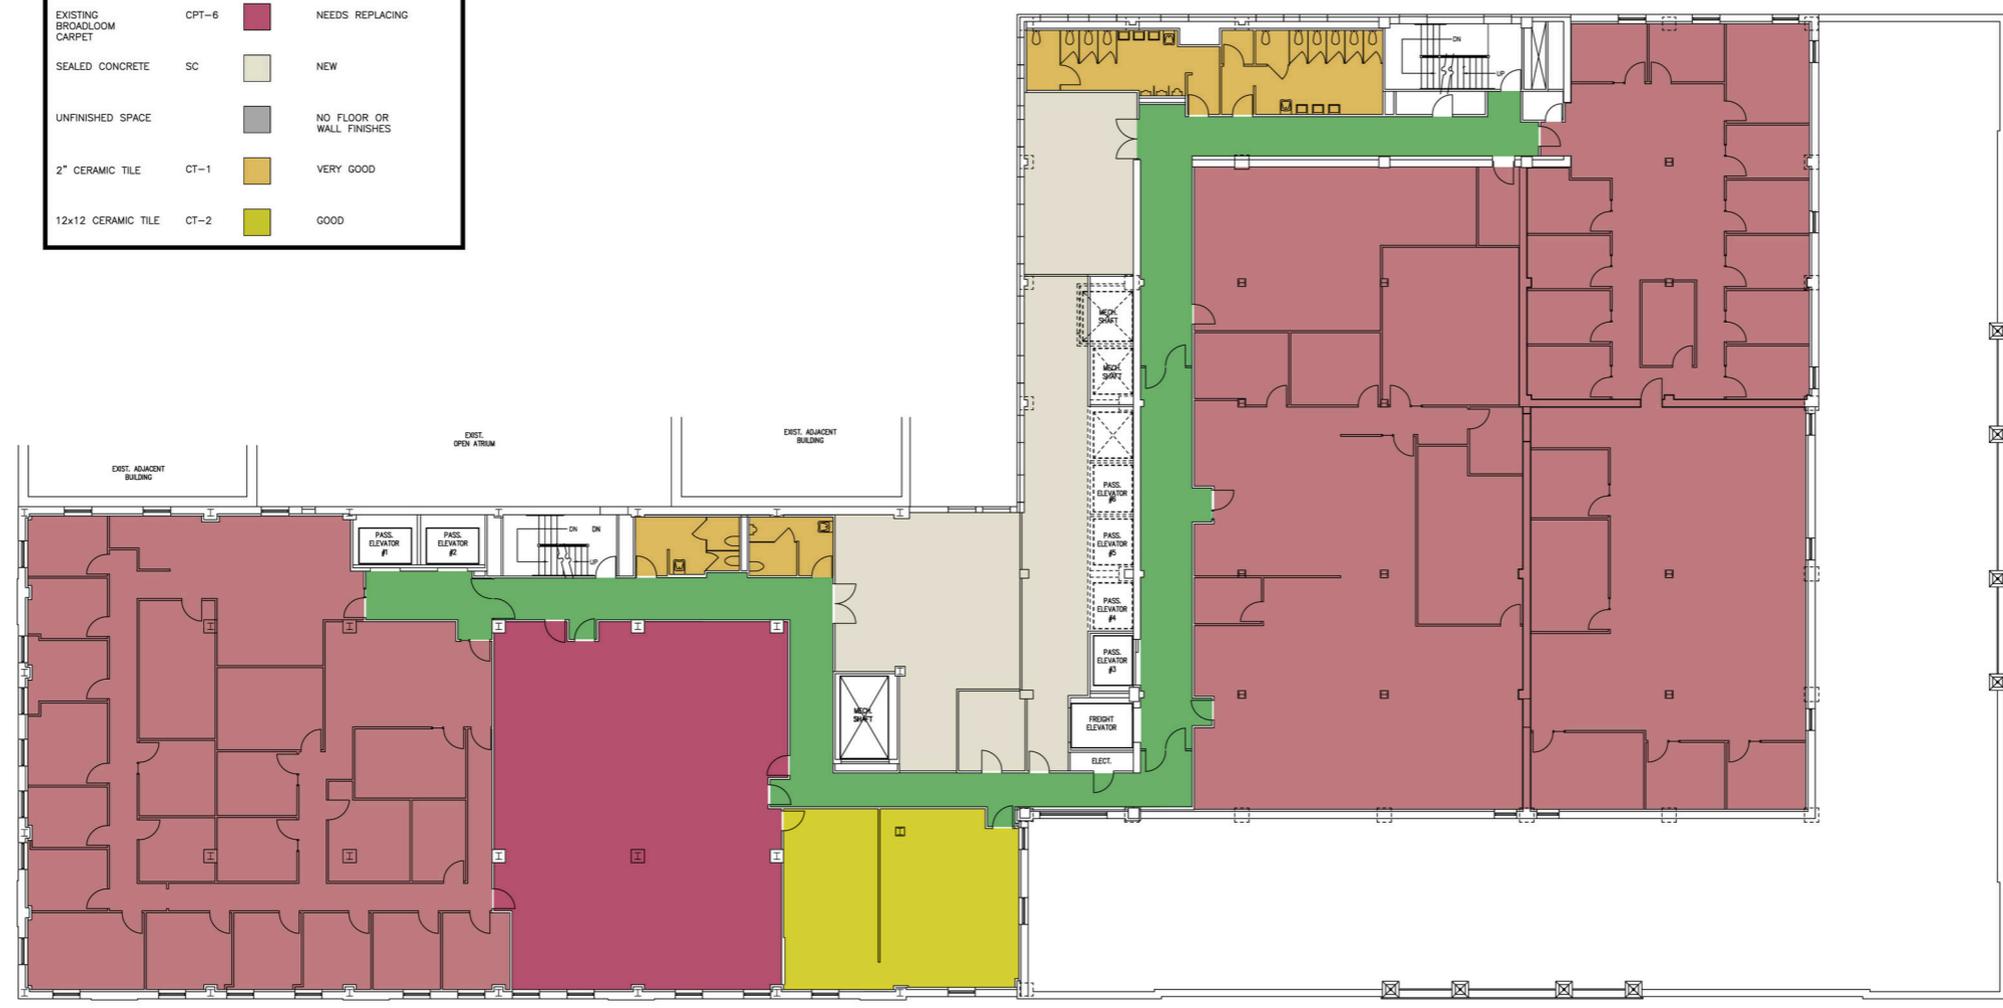
A SEVENTH FLOOR PLAN
3/32" = 1'-0"

FLOOR FINISH KEY		
		CONDITION
CARPET	CPT-1	WORN REPLACEMENT RECOMMENDED
CARPET	CPT-2.0	GOOD
CARPET	CPT-2.1	FAIR REPLACEMENT NEAR FUTURE
VCT	VCT-1	GOOD
CARPET	CPT-3	WORN REPLACEMENT RECOMMENDED
CARPET	CPT-4	WORN REPLACEMENT RECOMMENDED
CARPET	CPT-5	GOOD
EXISTING BROOKLOOM CARPET	CPT-6	NEEDS REPLACING
SEALED CONCRETE	SC	NEW
UNFINISHED SPACE		NO FLOOR OR WALL FINISHES
2" CERAMIC TILE	CT-1	VERY GOOD
12x12 CERAMIC TILE	CT-2	GOOD
